**RE: Asbestos Survey Report  
Kroger Store D-442 Renovation  
17447 Haggerty Road  
Northville, Michigan  
Project No. 343-681.0001**

**NESHAP Renovation Asbestos Survey Report**

**Existing Kroger Store D-442  
17447 Haggerty Road  
Northville, Michigan 48168**

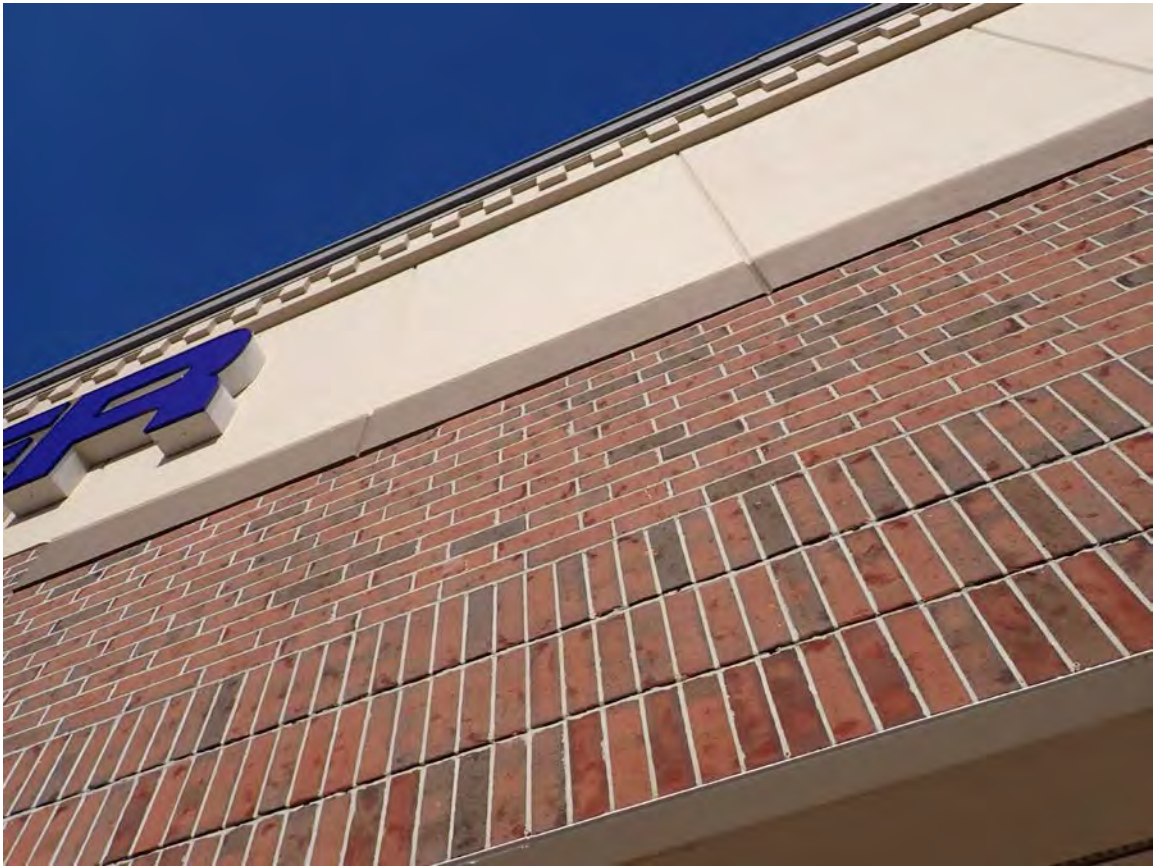
**Existing Kroger Store D-442**  
Exterior Upper Level  
**Exterior Finishing System**

**No Asbestos Detected**

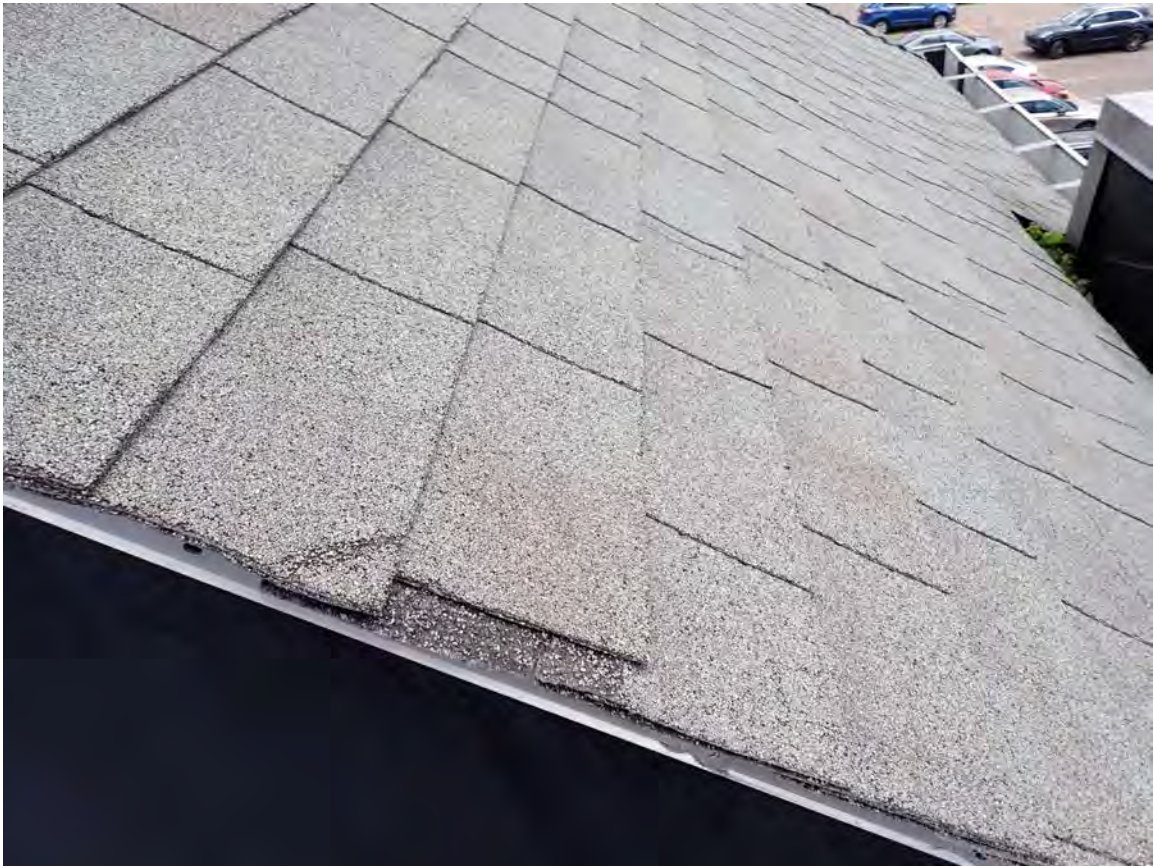
**Existing Kroger Store D-442**  
Roof – East Side  
**Asphalt Roofing Shingles and Underlayment**  
**No Asbestos Detected**

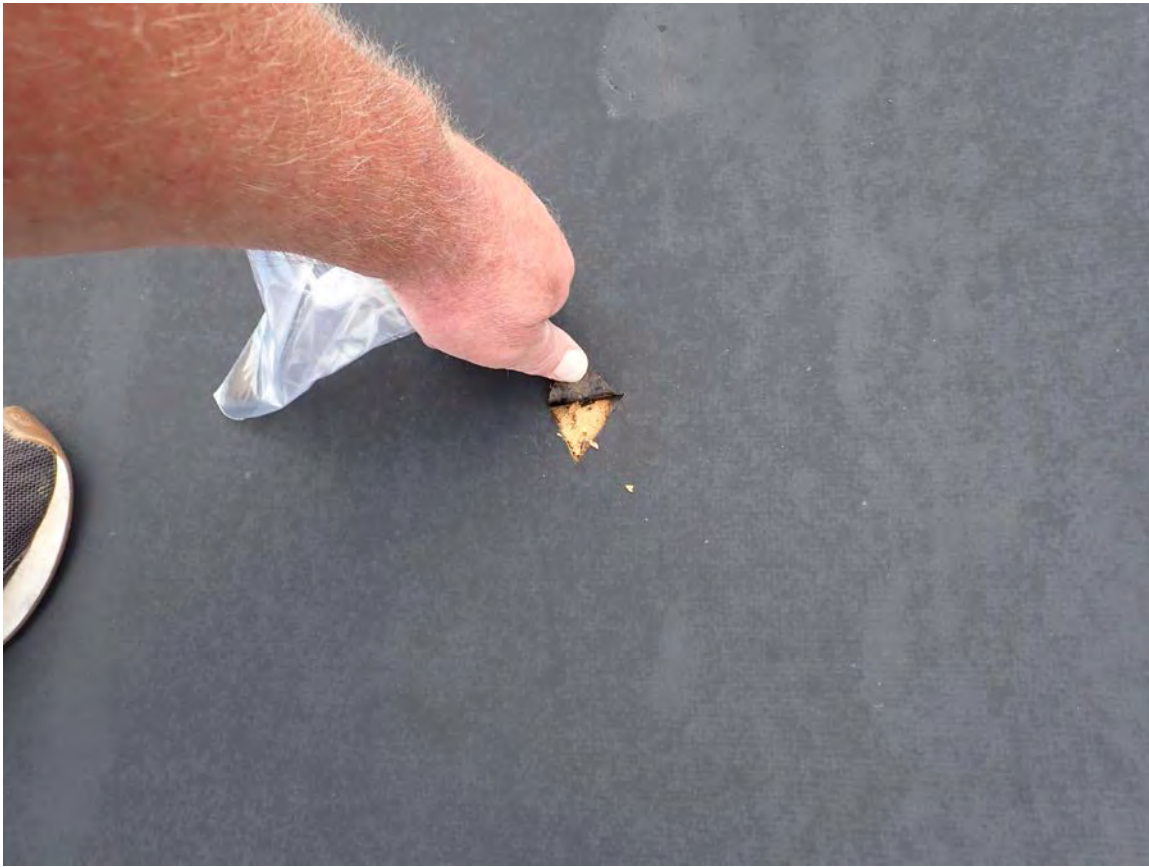
**Existing Kroger Store D-442**  
Main Roof  
**Roofing Felt under Rubber Membrane Roof**  
**No Asbestos Detected**

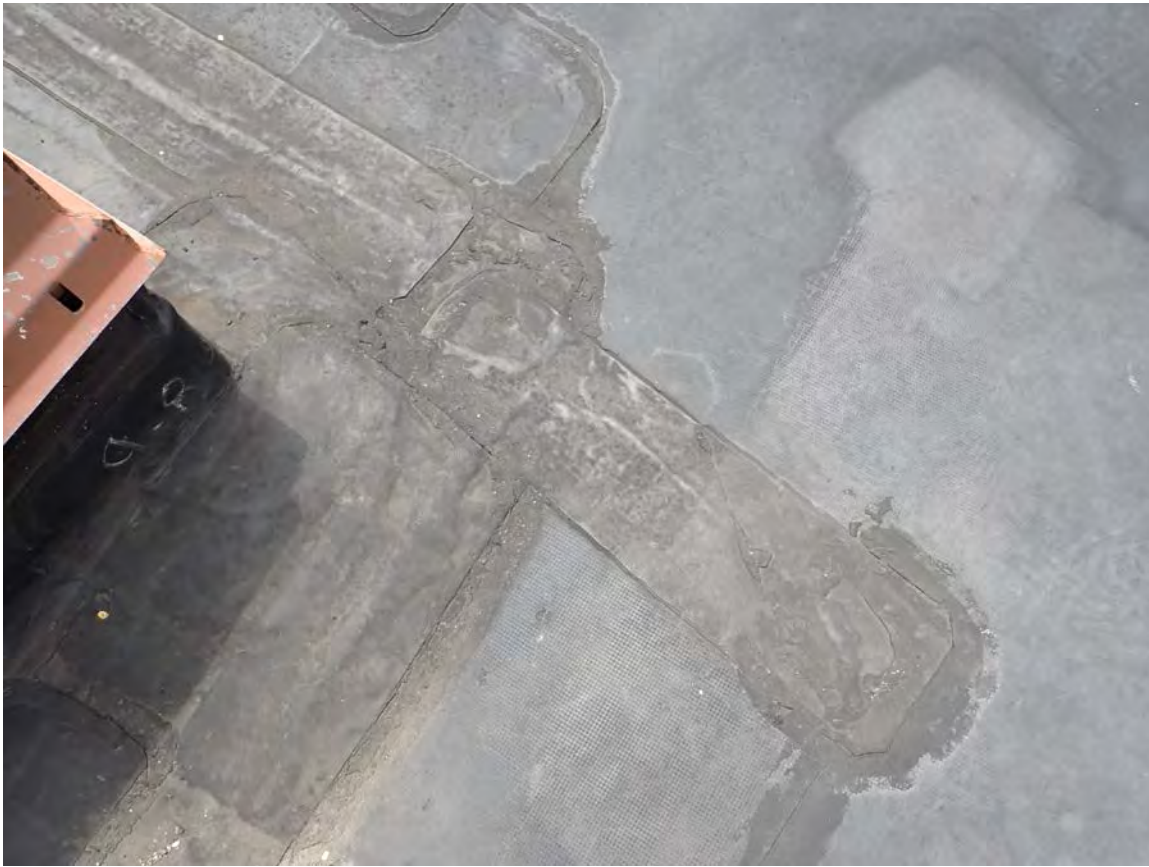
**Existing Kroger Store D-442**  
Main Roof  
**Rubber Membrane Roof Seam Caulk**  
**No Asbestos Detected**

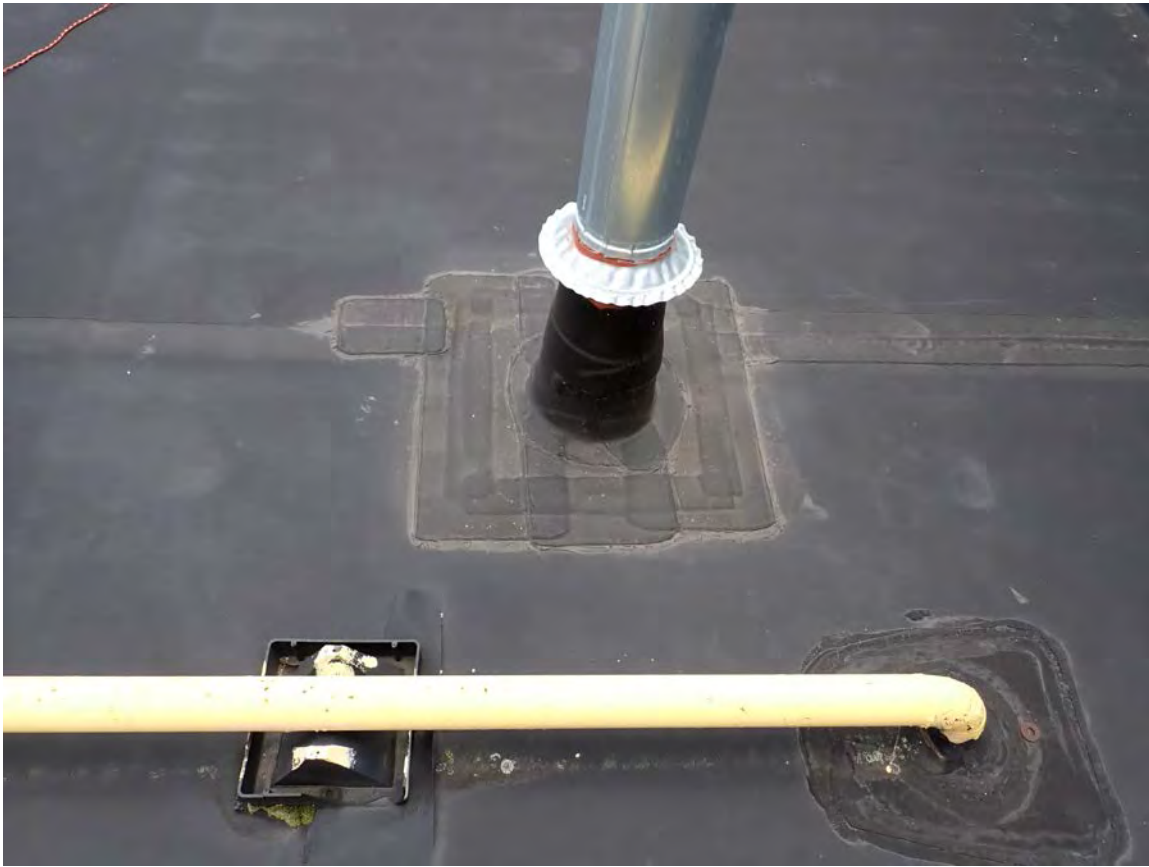
**Main Roof**

**Roof Penetration Caulk**

**No Asbestos Detected**

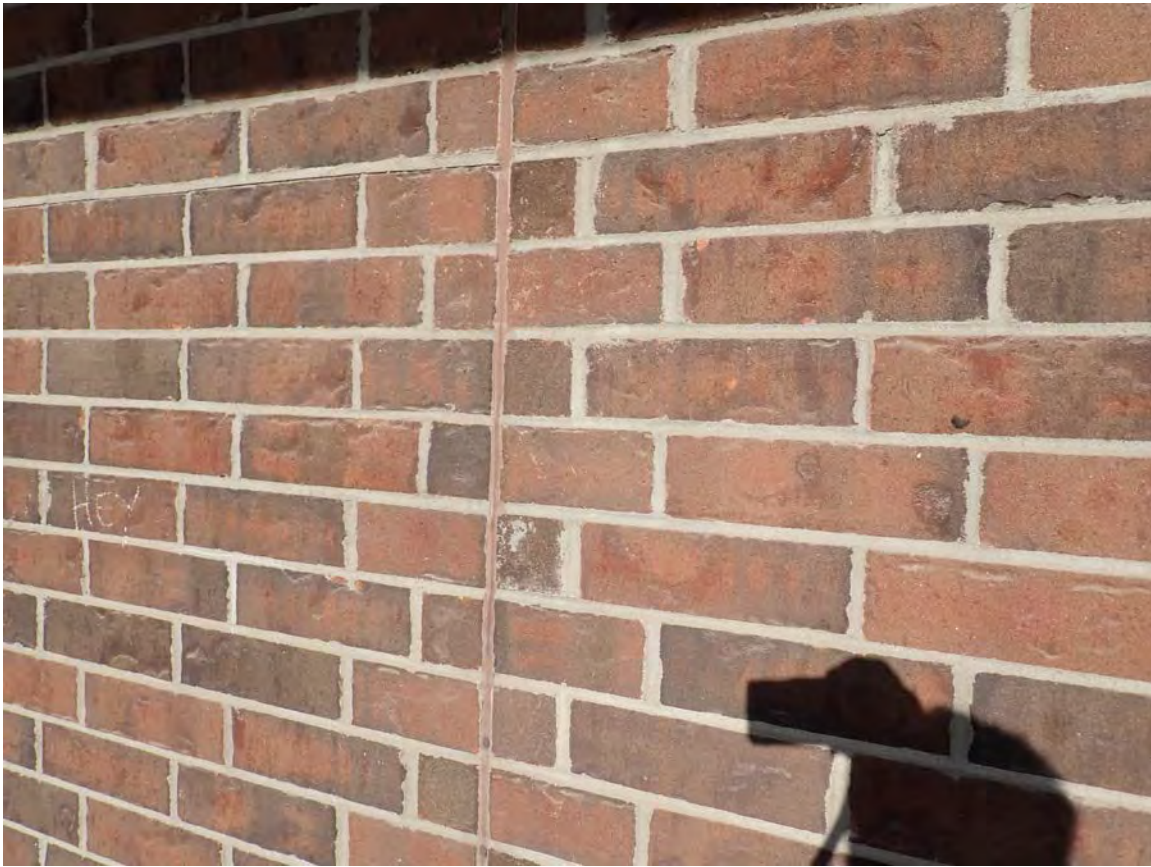
**Existing Kroger Store D-442**  
Exterior  
**Brick Mortar and Expansion Joint**

**No Asbestos Detected**

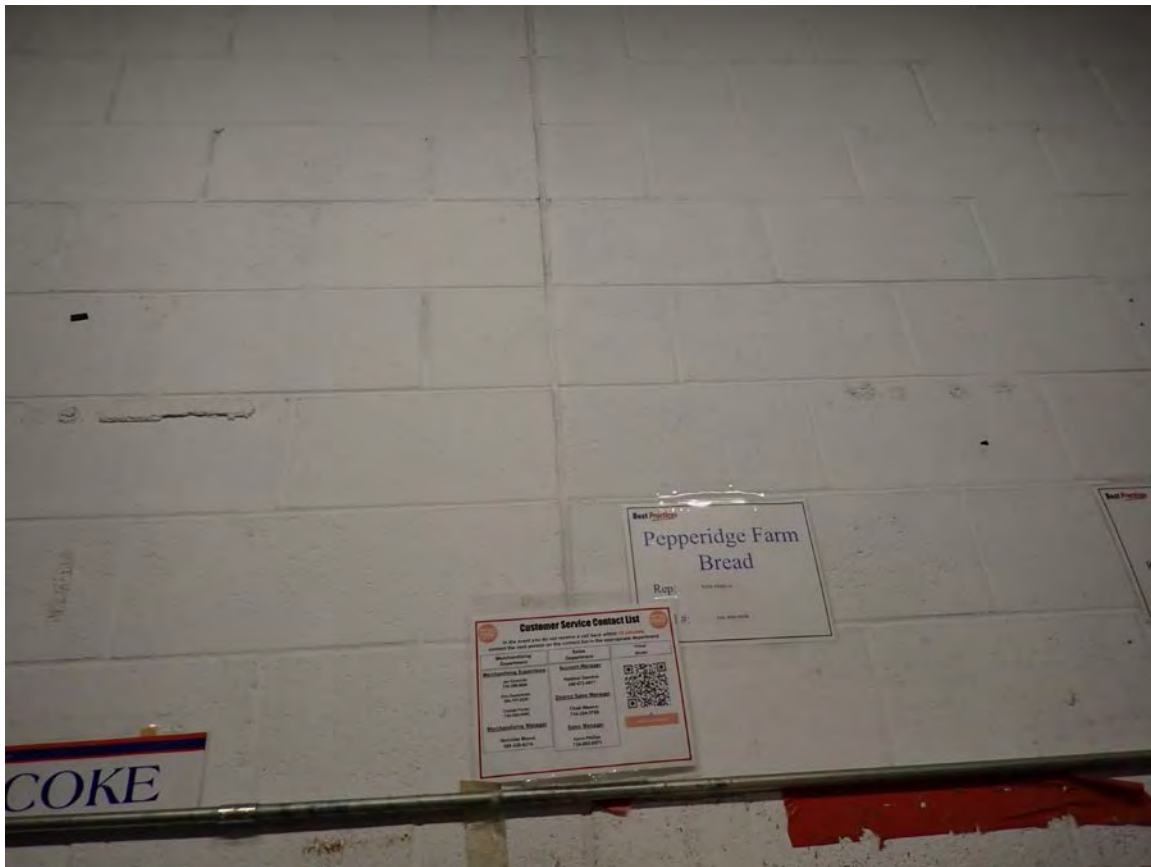
**Existing Kroger Store D-442  
Warehouse  
Concrete Block Mortar and Expansion Joint

No Asbestos Detected**

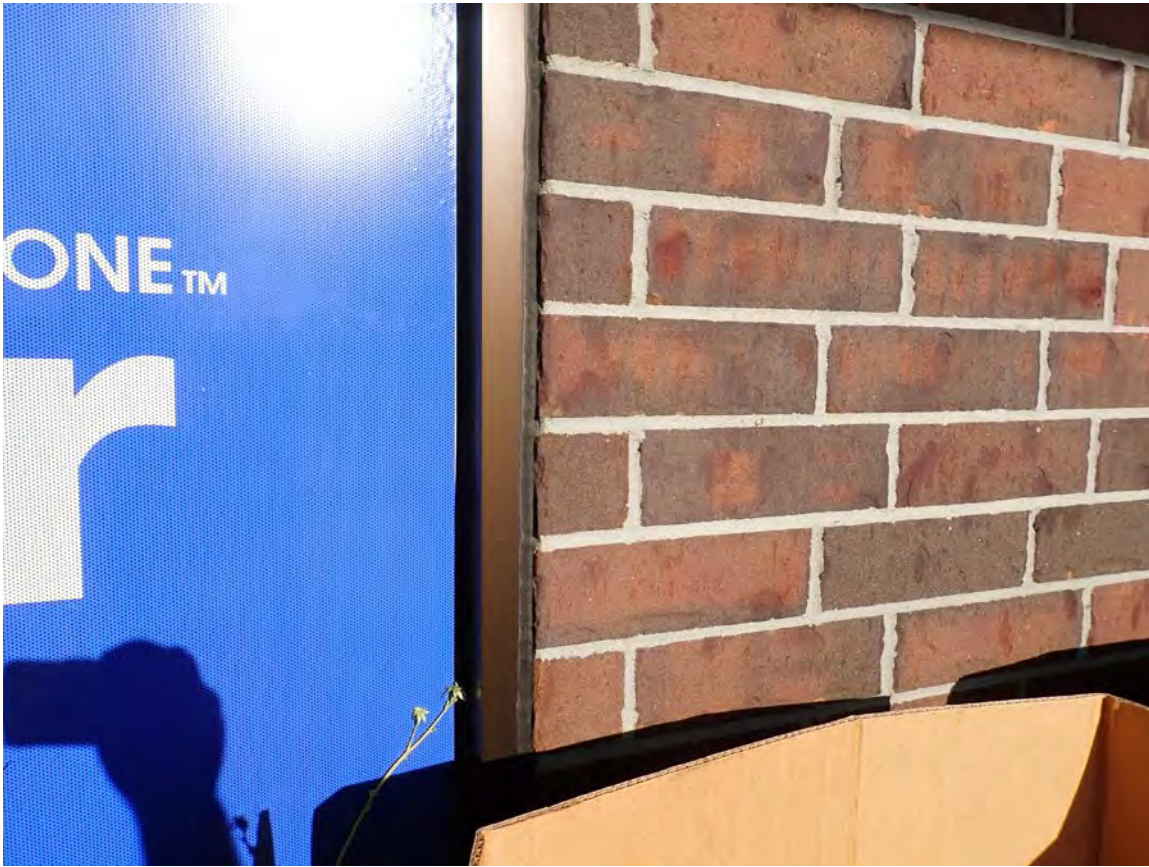
**Existing Kroger Store D-442**  
Exterior Windows and Doors, Mezzanine  
**Window/Door Frame Caulk and Window Glazing Material**

**No Asbestos Detected**

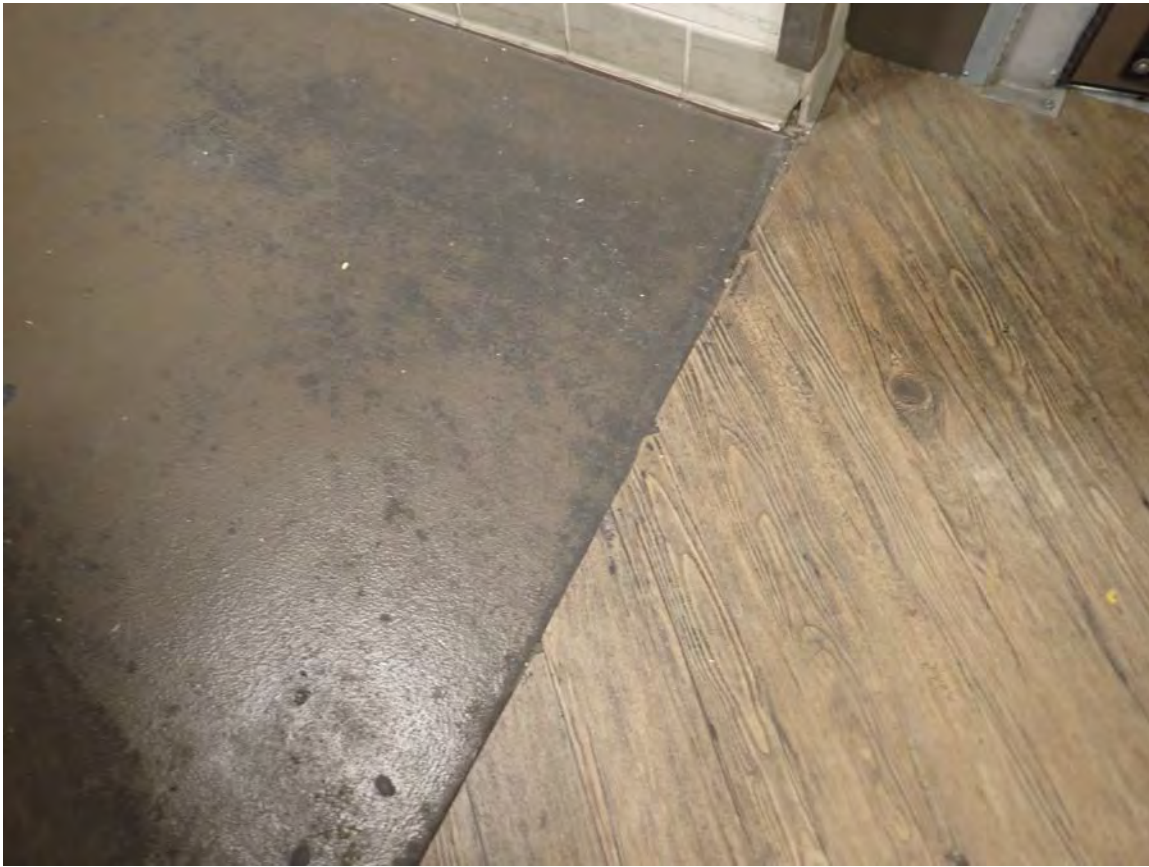
**Existing Kroger Store D-442**  
Recycling Center, Food Prep Areas  
**Poured Flooring**

**No Asbestos Detected**

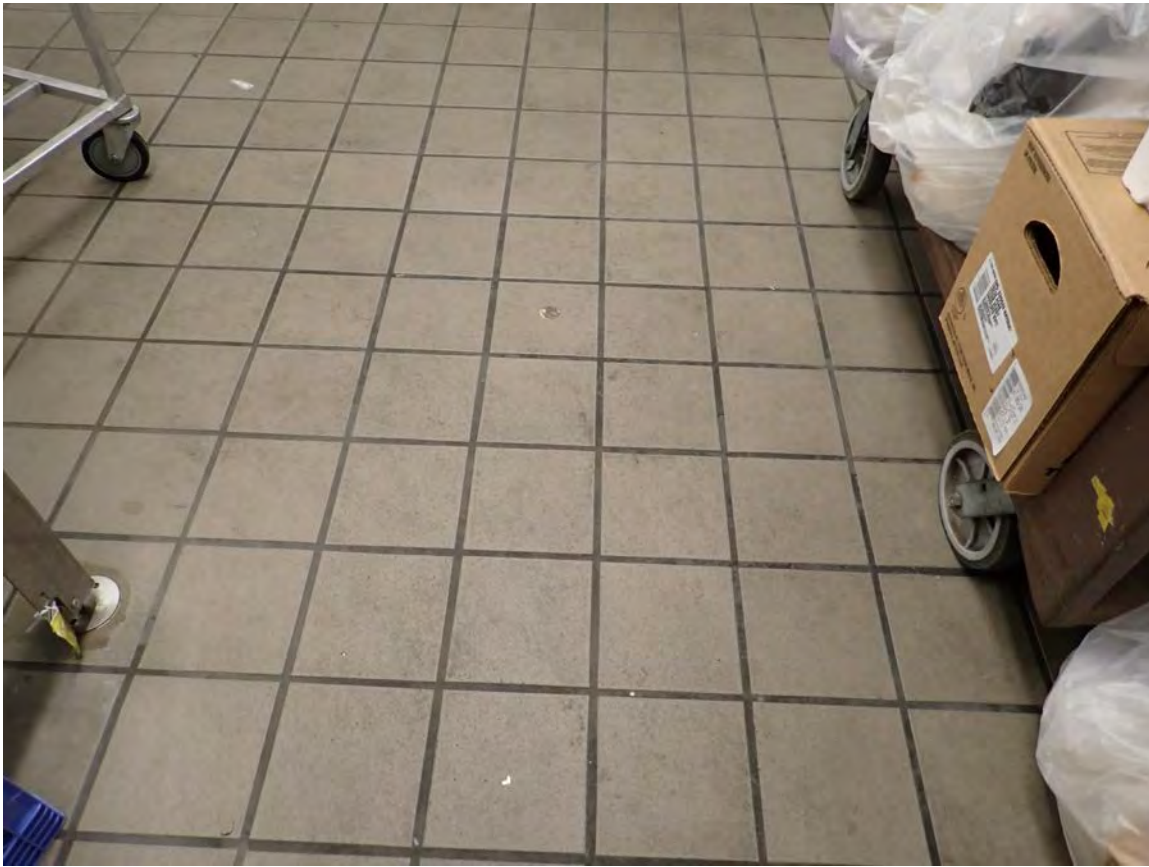
**Existing Kroger Store D-442**  
Meat Prep Area and Vestibules  
**Clay Floor Tile Grout**

**No Asbestos Detected**

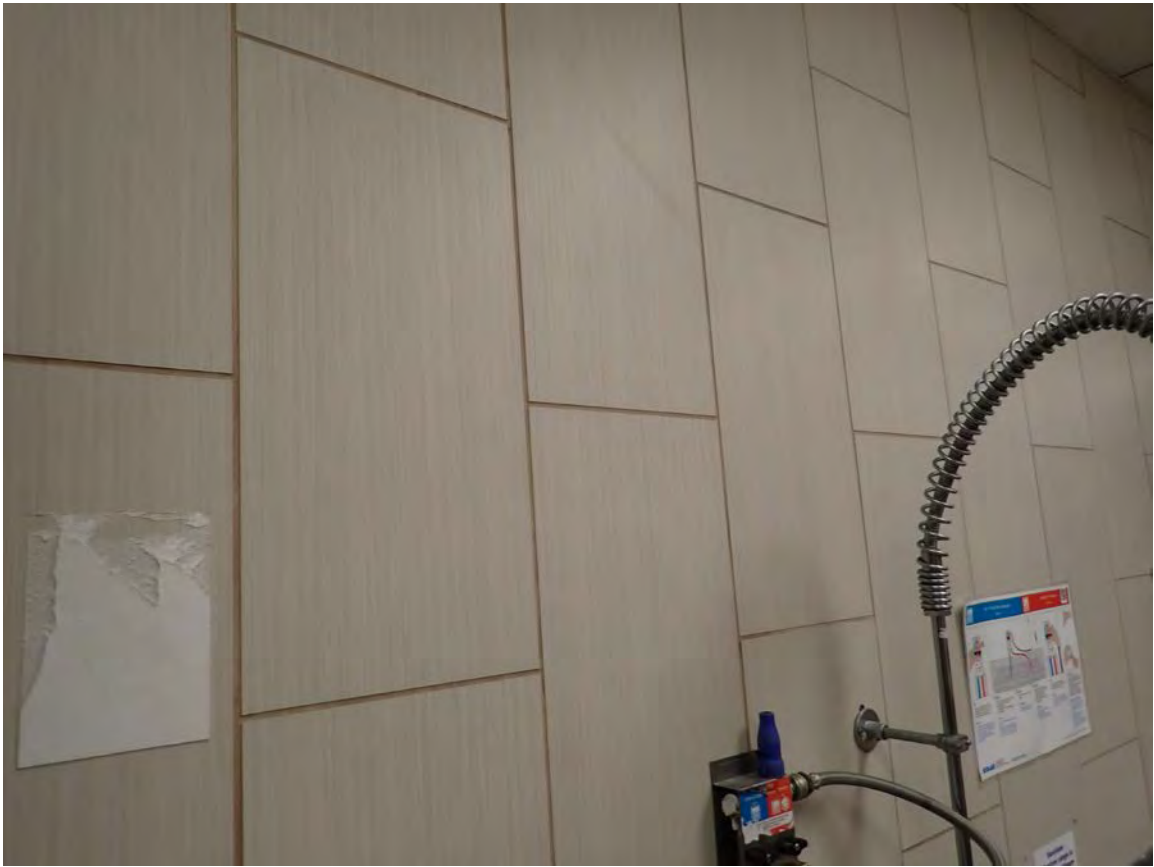
**Existing Kroger Store D-442**  
Food Prep Areas and Restrooms  
**Ceramic Wall Tile Grout**

**No Asbestos Detected**

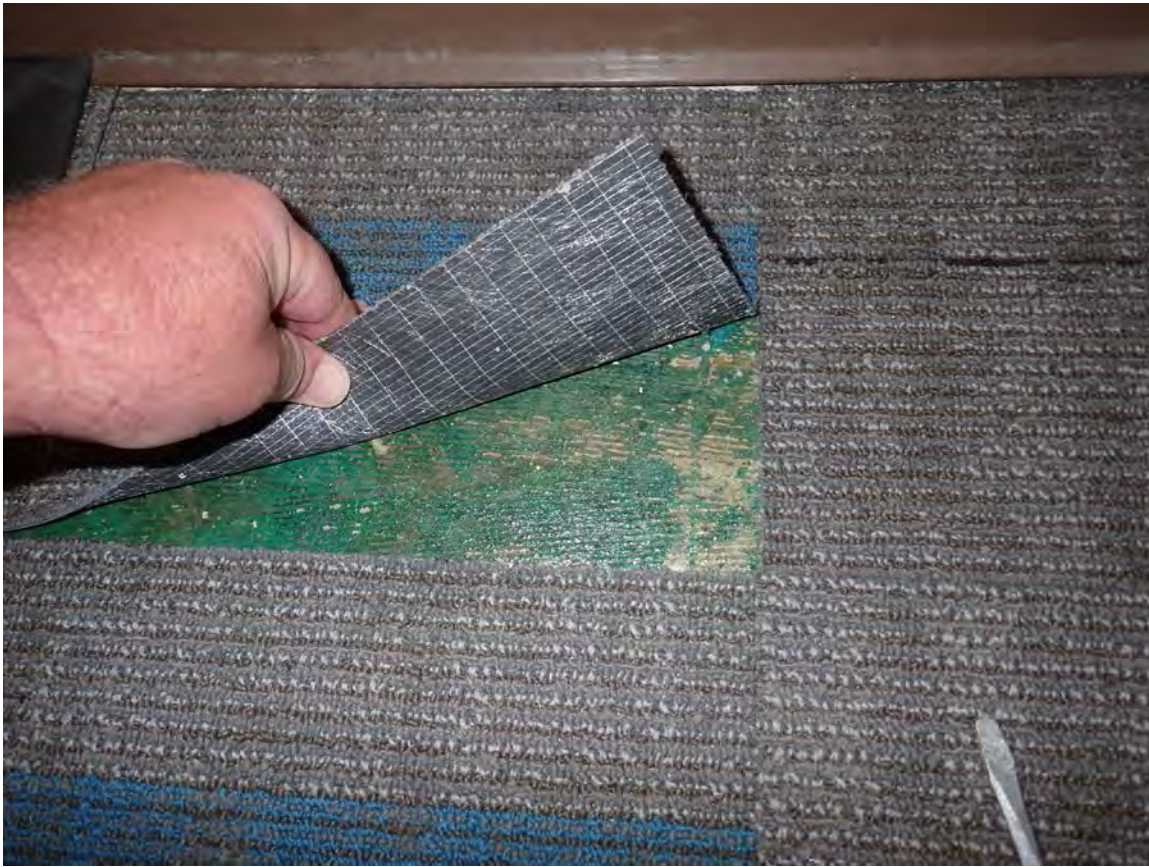
**Existing Kroger Store D-442**  
Pharmacy, Office Areas, and Customer Care  
**Carpet Tile Mastic**

**No Asbestos Detected**

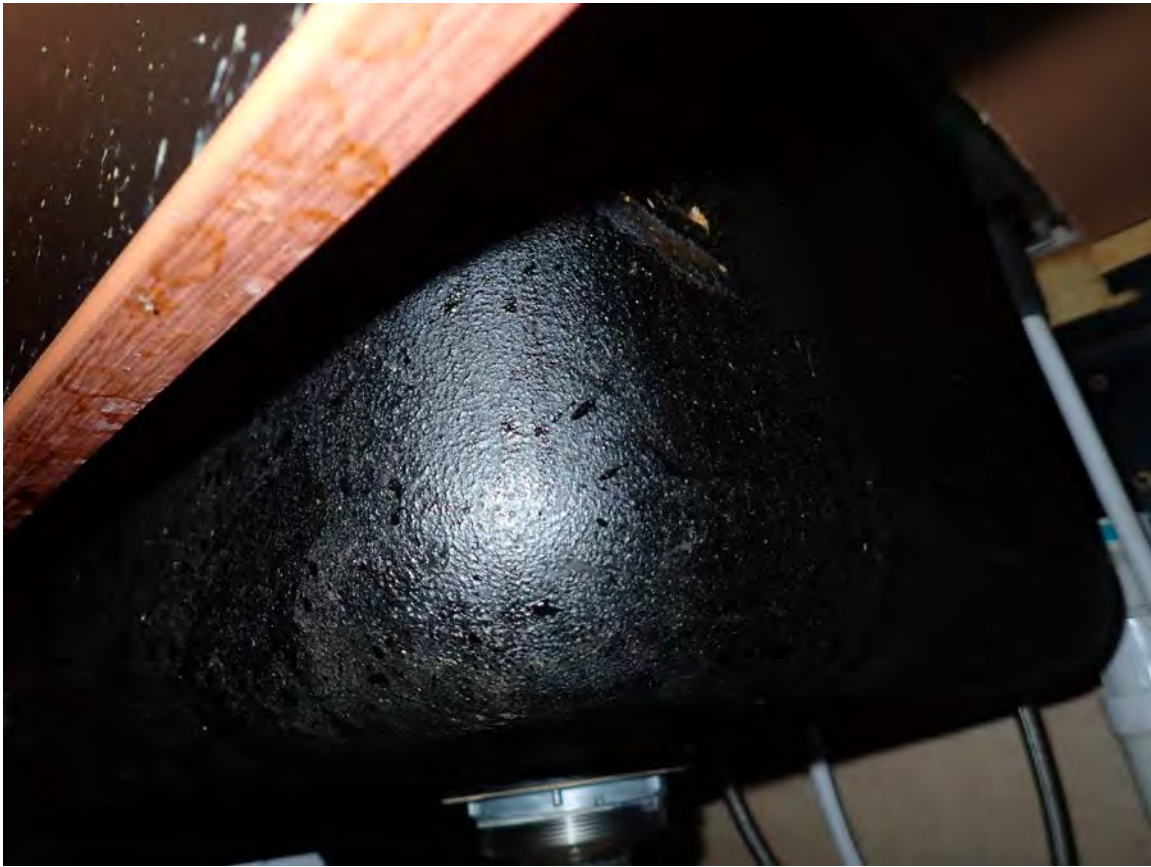
**Existing Kroger Store D-442**  
Floral and Pharmacy Sinks  
**Stainless Steel Sink Insulation**

**No Asbestos Detected**

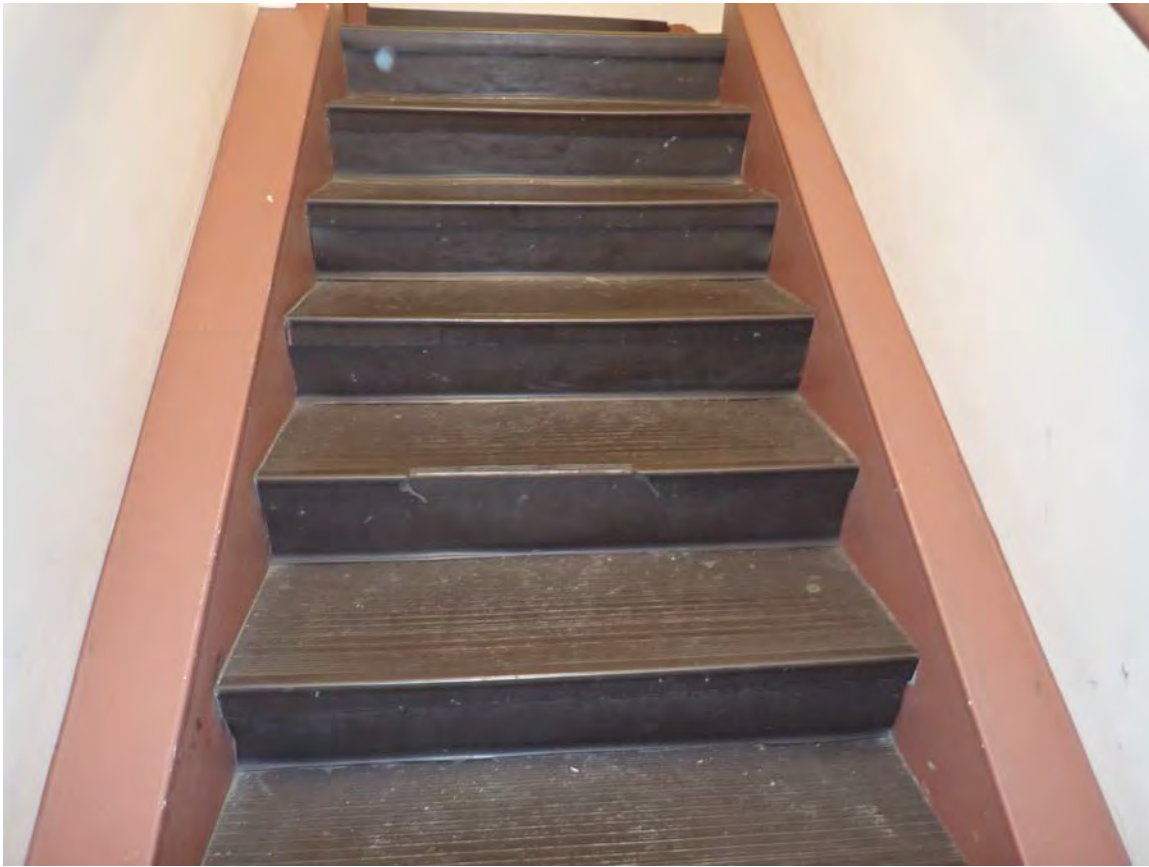
**Existing Kroger Store D-442**  
Mezzanine North and South Stairs  
**Vinyl Stair Tread Adhesive**

**No Asbestos Detected**

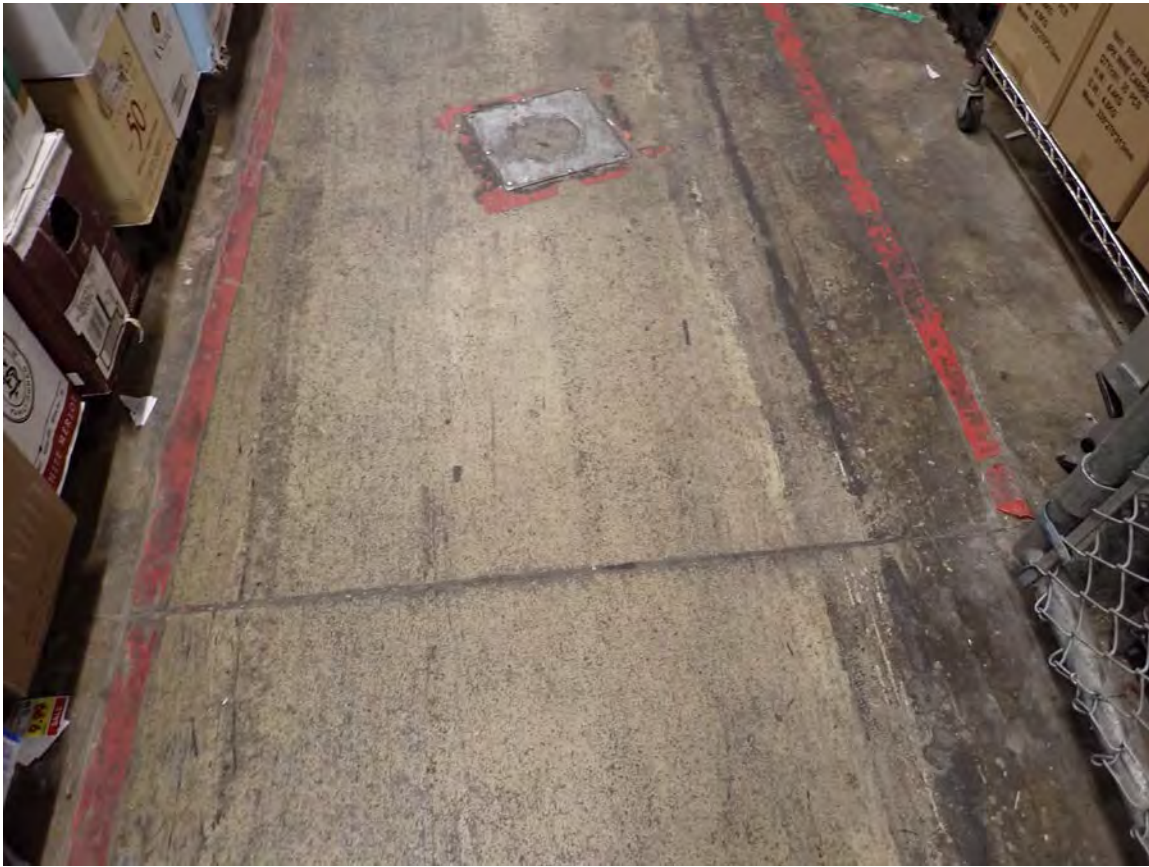
**Warehouse and Dock**

**Bare Concrete Flooring**

**No Asbestos Detected**

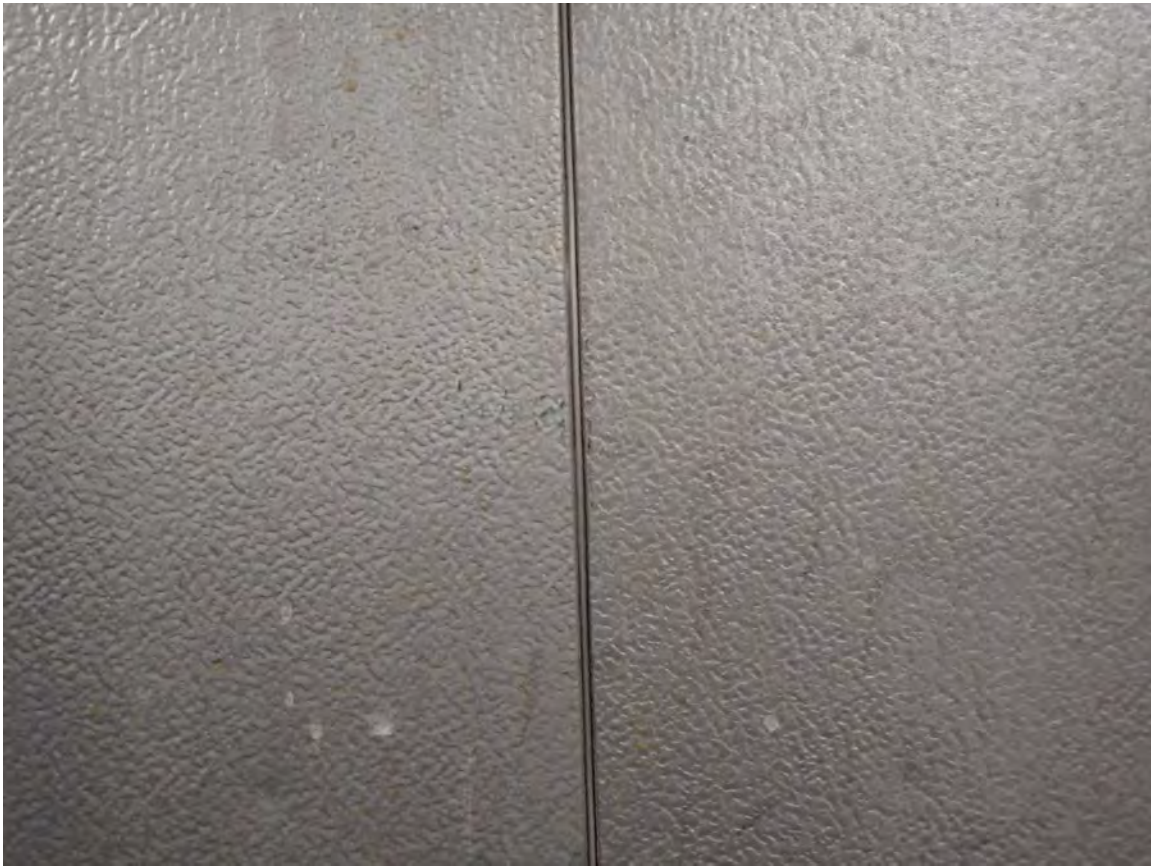
**Existing Kroger Store D-442**  
Freezers and Coolers  
**Freezer/Cooler Panel Insulation and Seam Putty**

**No Asbestos Detected**

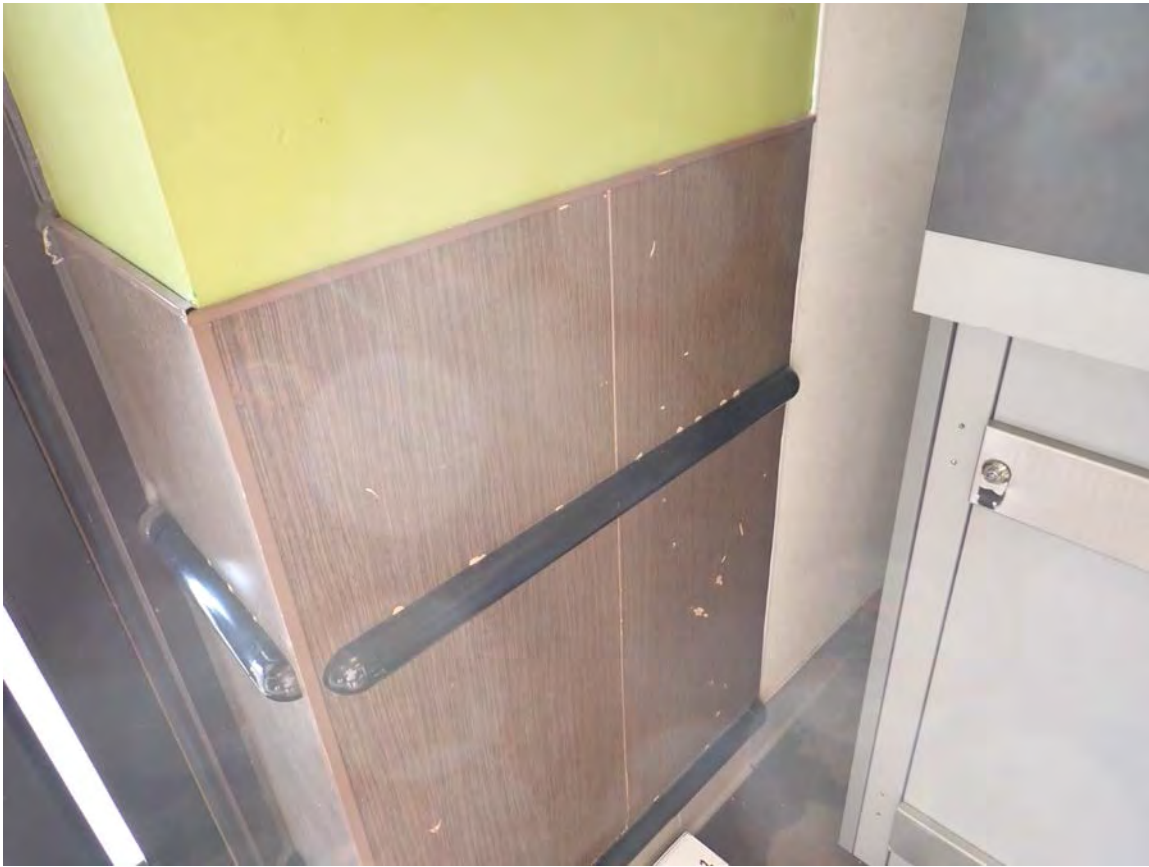
**Existing Kroger Store D-442**  
Store Lower Walls  
**Plastic Wall Panel Adhesive**

**No Asbestos Detected**

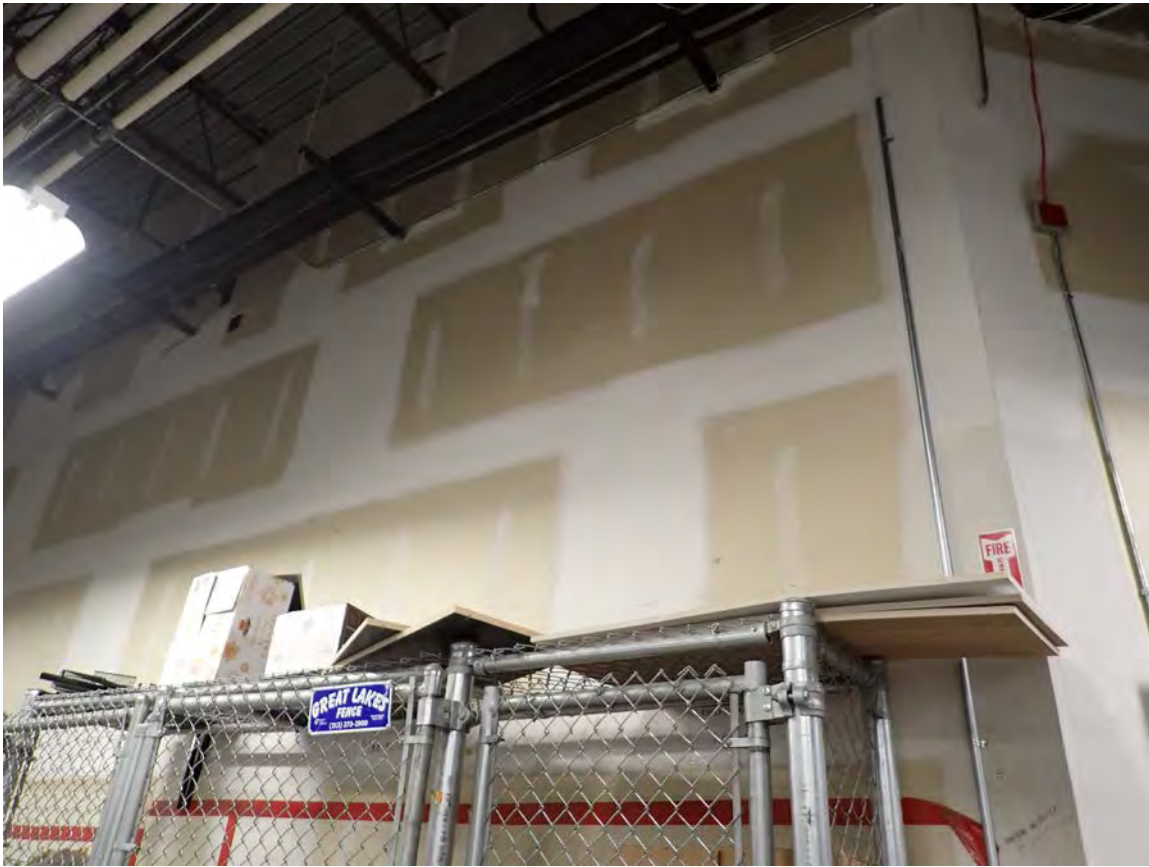
**Existing Kroger Store D-442**  
Interior and Perimeter Walls  
**Drywall and Associated Joint Compound**

**No Asbestos Detected**

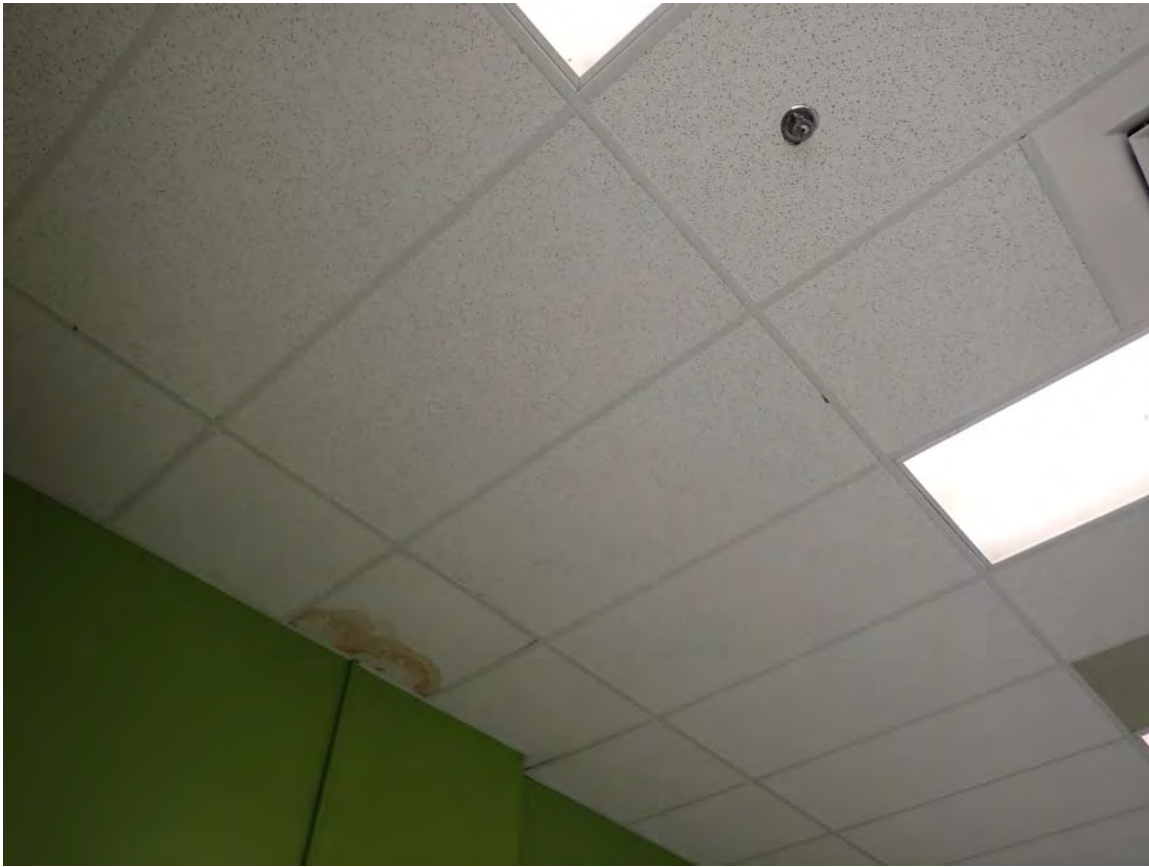
**Existing Kroger Store D-442**  
Recycling, Pharmacy, Restroom Hall  
**2' x 4' Acoustical Ceiling Tile (birdtrack pattern)**

**No Asbestos Detected**

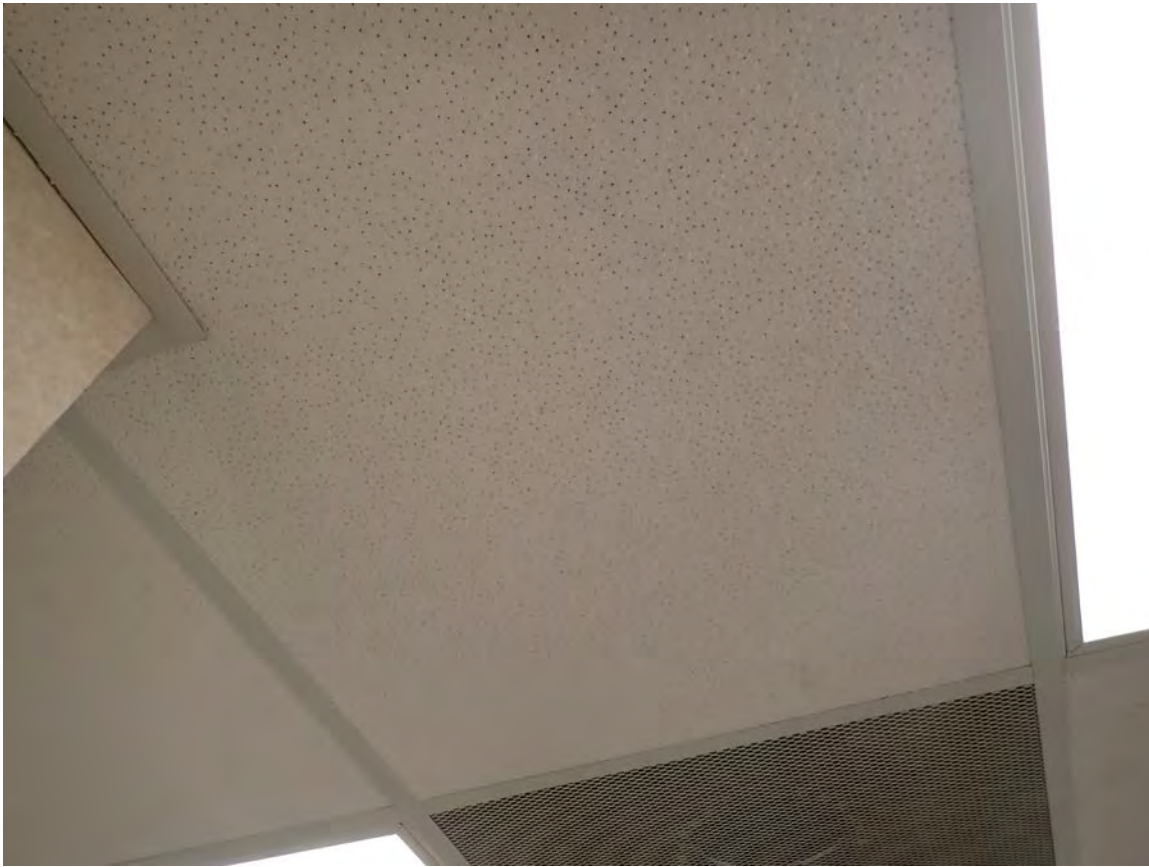
**Existing Kroger Store D-442**  
Office Areas  
**2' x 4' Acoustical Ceiling Tile (pinhole pattern)**  
**No Asbestos Detected**

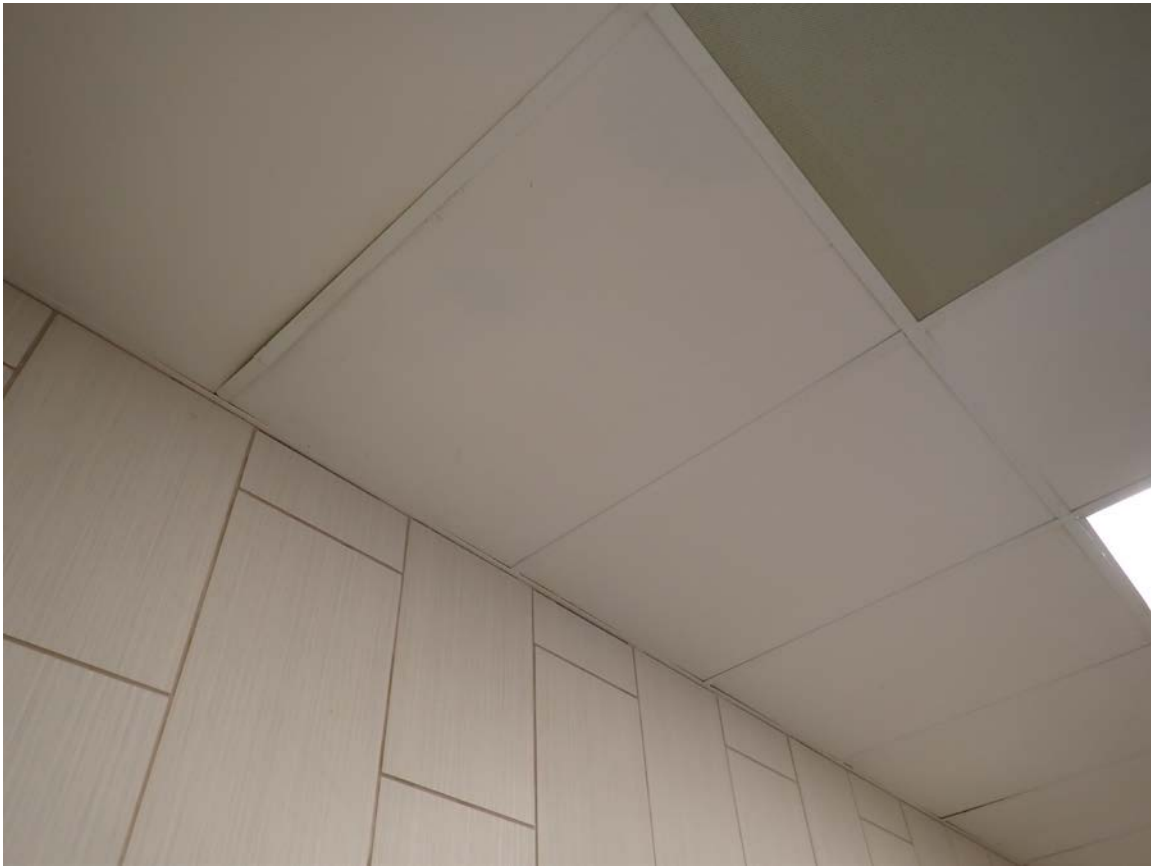
**Existing Kroger Store D-442**  
Food Prep Areas  
**2' x 4' Acoustical Ceiling Tile (drywall pattern)**  
**No Asbestos Detected**

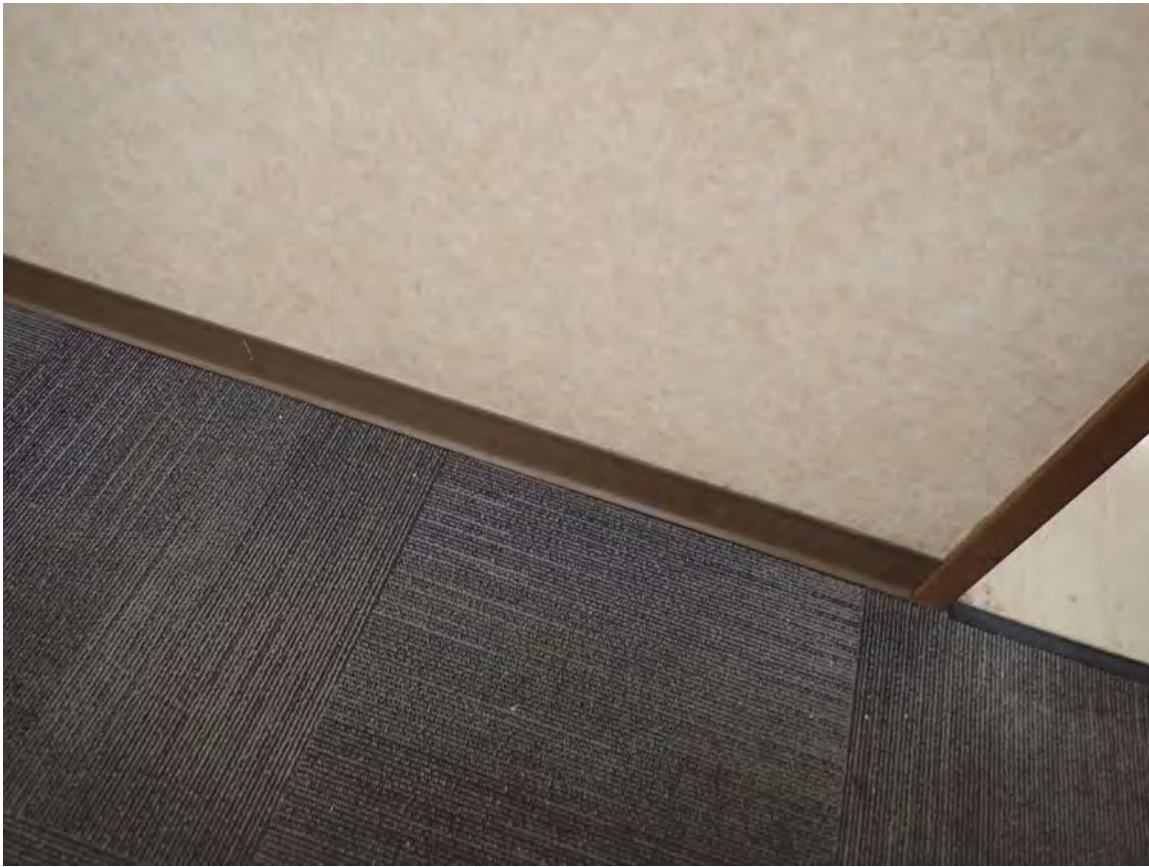
**Existing Kroger Store D-442**  
Throughout Store Floor and Mezzanine  
**Vinyl Base Molding and Adhesive**

**No Asbestos Detected**
