**RE: Asbestos Survey Report  
Kroger Store D-442 Renovation  
17447 Haggerty Road  
Northville, Michigan  
Project No. 343-681.0001**

**NESHAP Renovation Asbestos Survey Report**

**Existing Kroger Store D-442  
17447 Haggerty Road  
Northville, Michigan 48168**

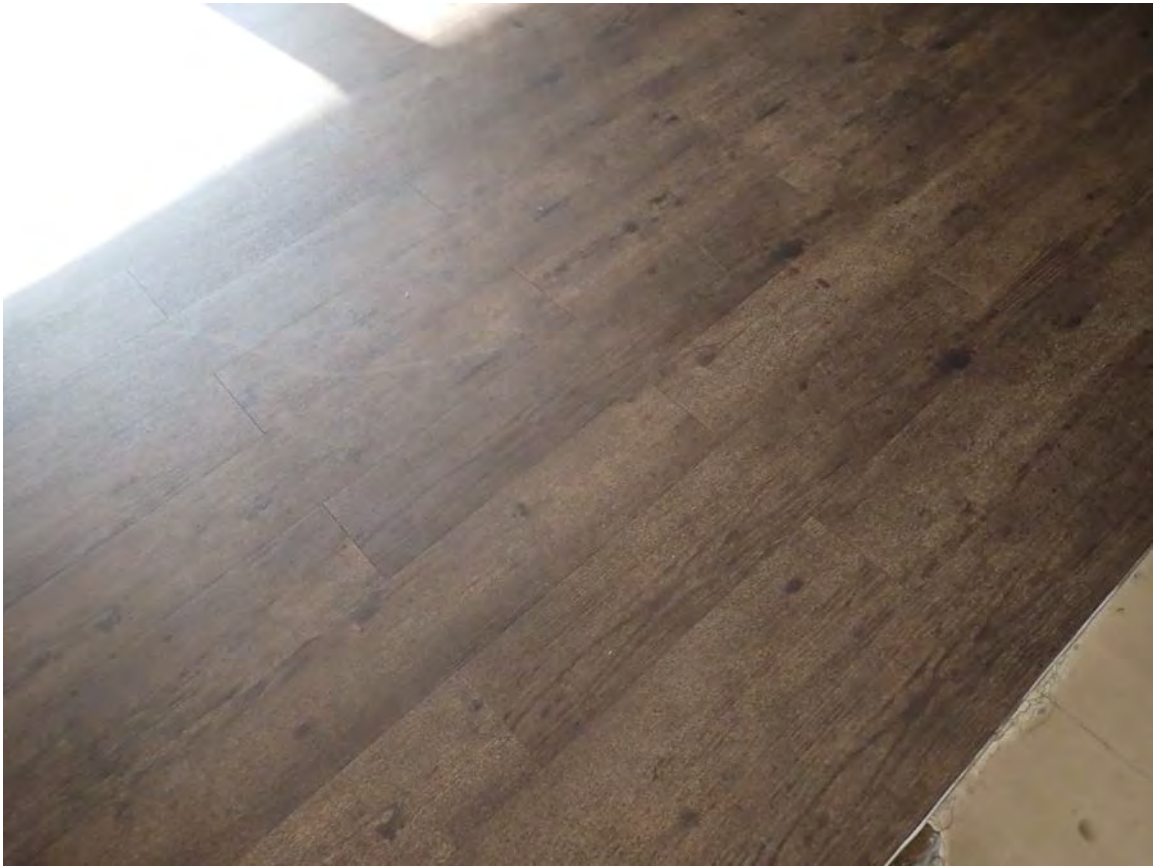
**Existing Kroger Store D-442**  
Produce, Adult Beverage, Vestibules, and Mezzanine  
**Woodgrain Linoleum and Adhesive**

**No Asbestos Detected**

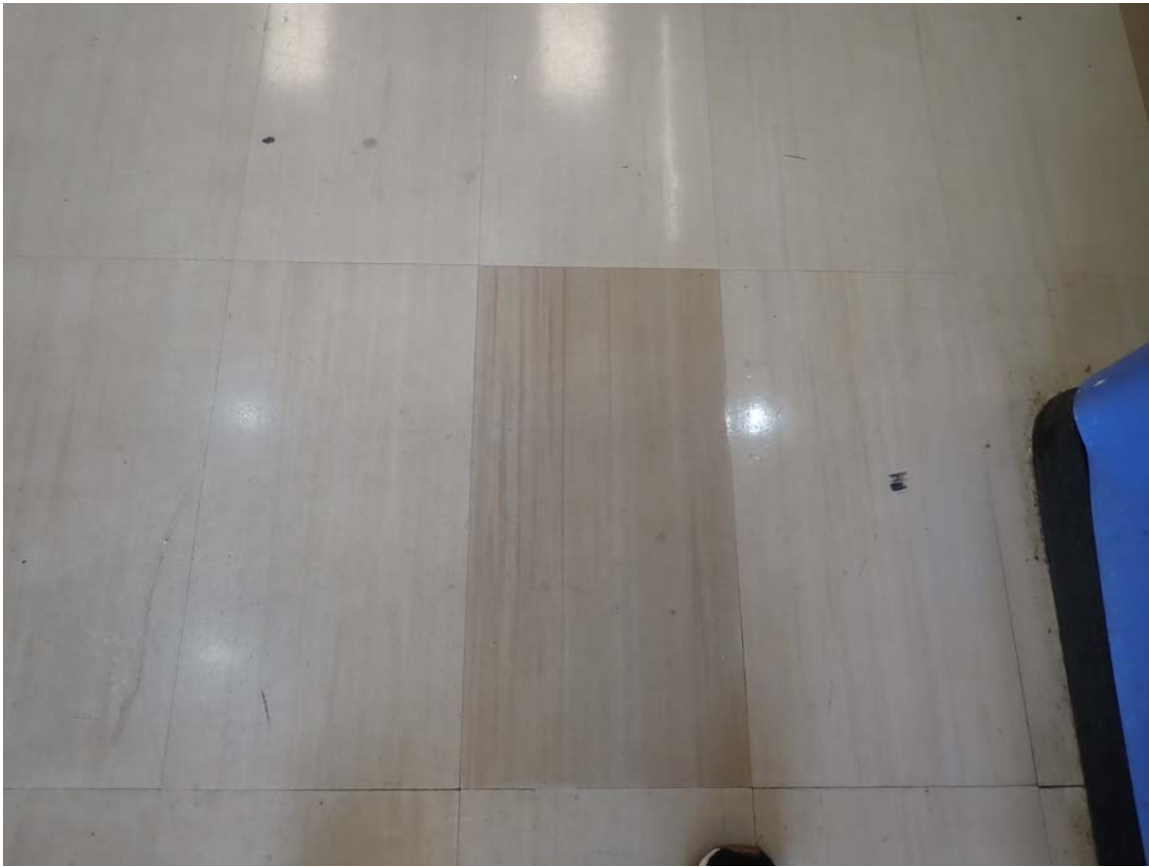
**Existing Kroger Store D-442**  
Store Floor  
**12" x 24" Tan and Brown Floor Tile and Mastic**  
**No Asbestos Detected**

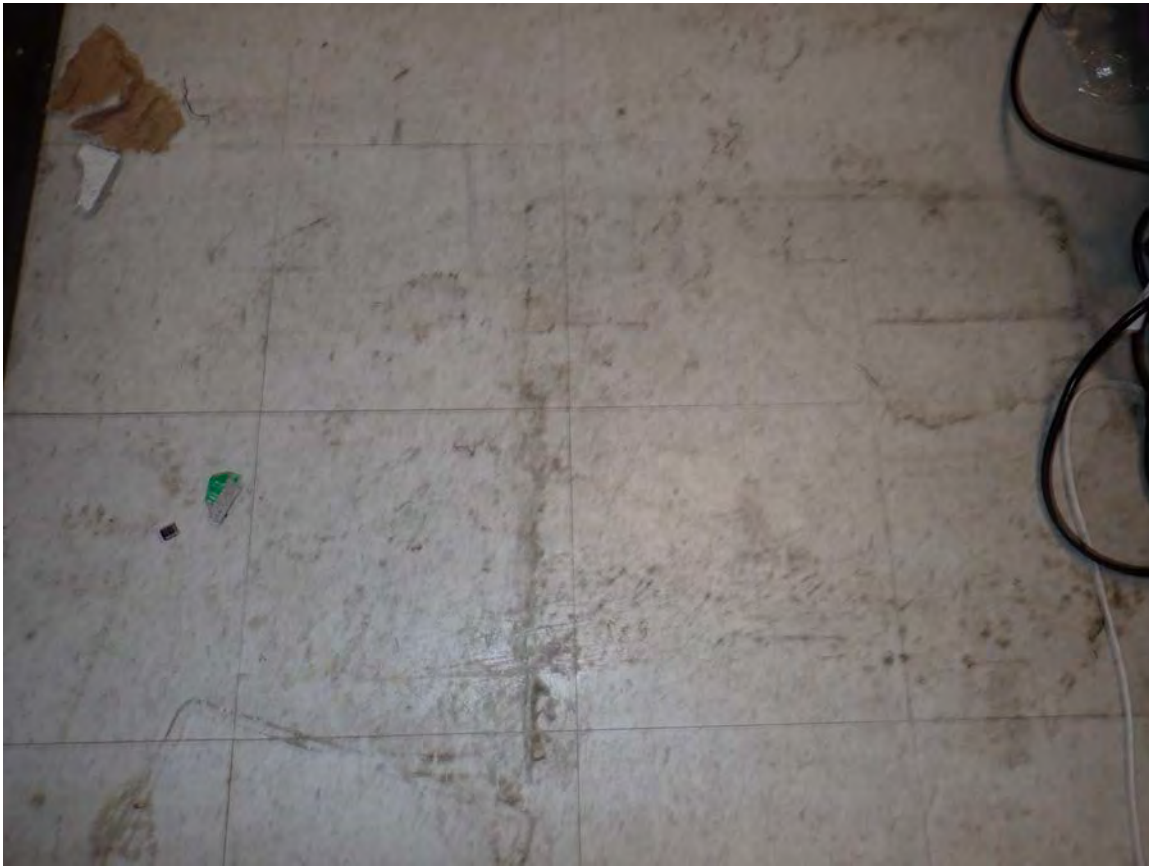
**Existing Kroger Store D-442**  
ECR  
**12" x 12" White Scale Pattern Floor Tile and Mastic**  
**No Asbestos Detected**

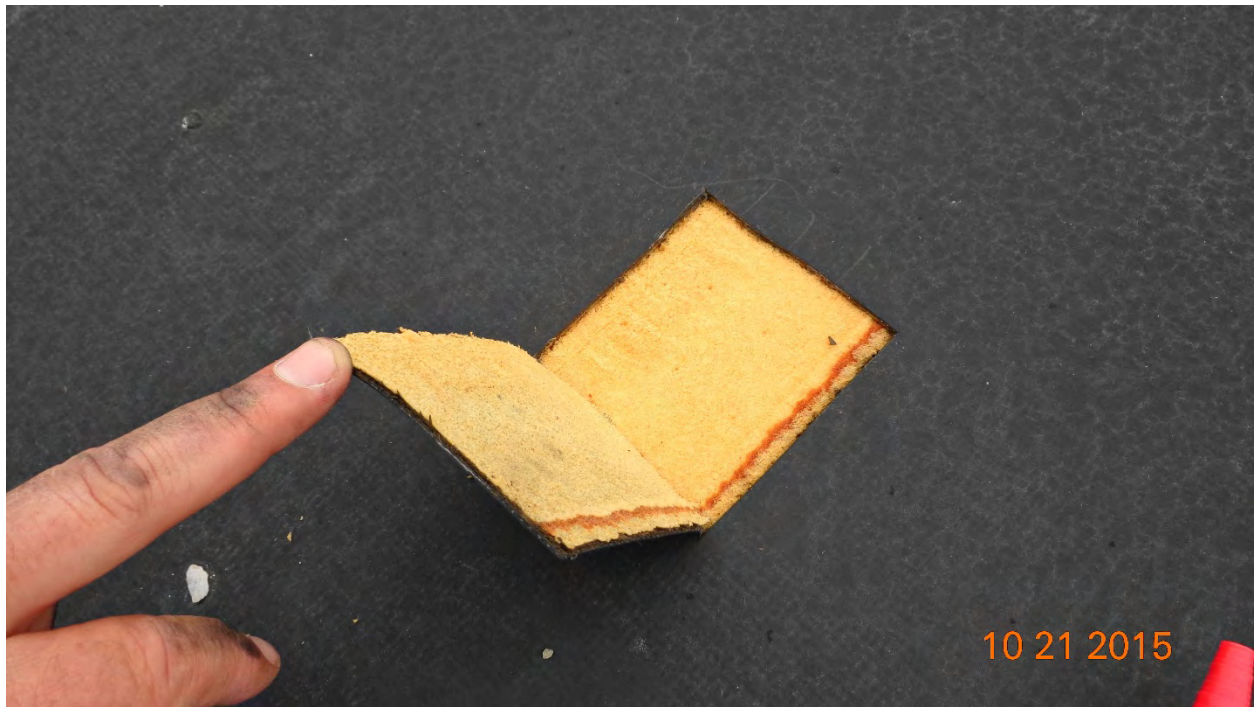
Roof

**Non-Suspect Isocyanate Roofing Board Beneath Rubber Membrane**

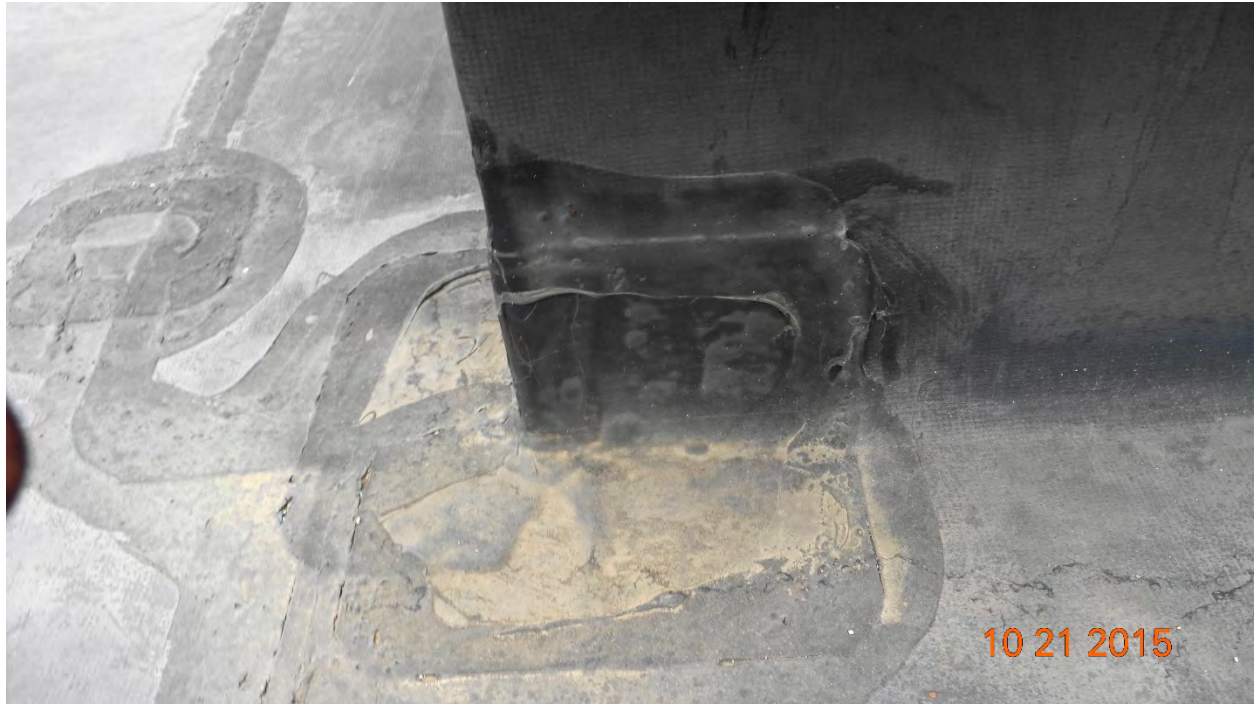
Roof Cement at Rubber Membrane Roof

**No Asbestos Detected**

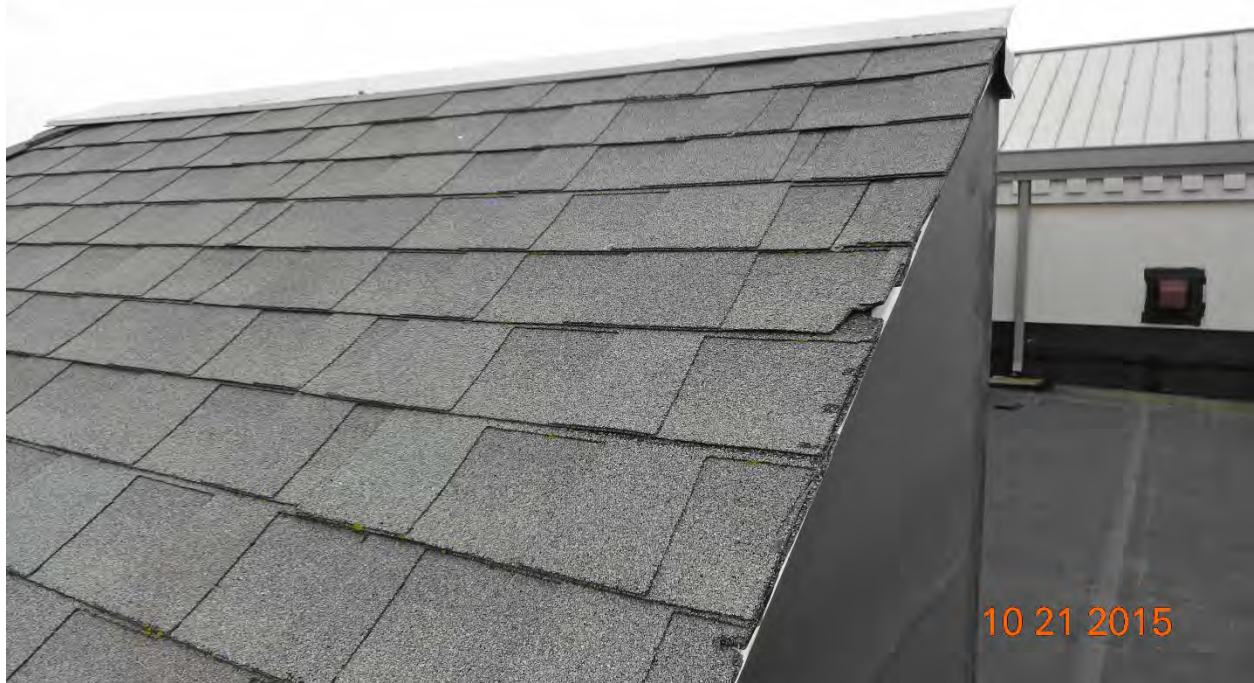
Roof-North End

Asphalt Roof Shingles

**No Asbestos Detected**

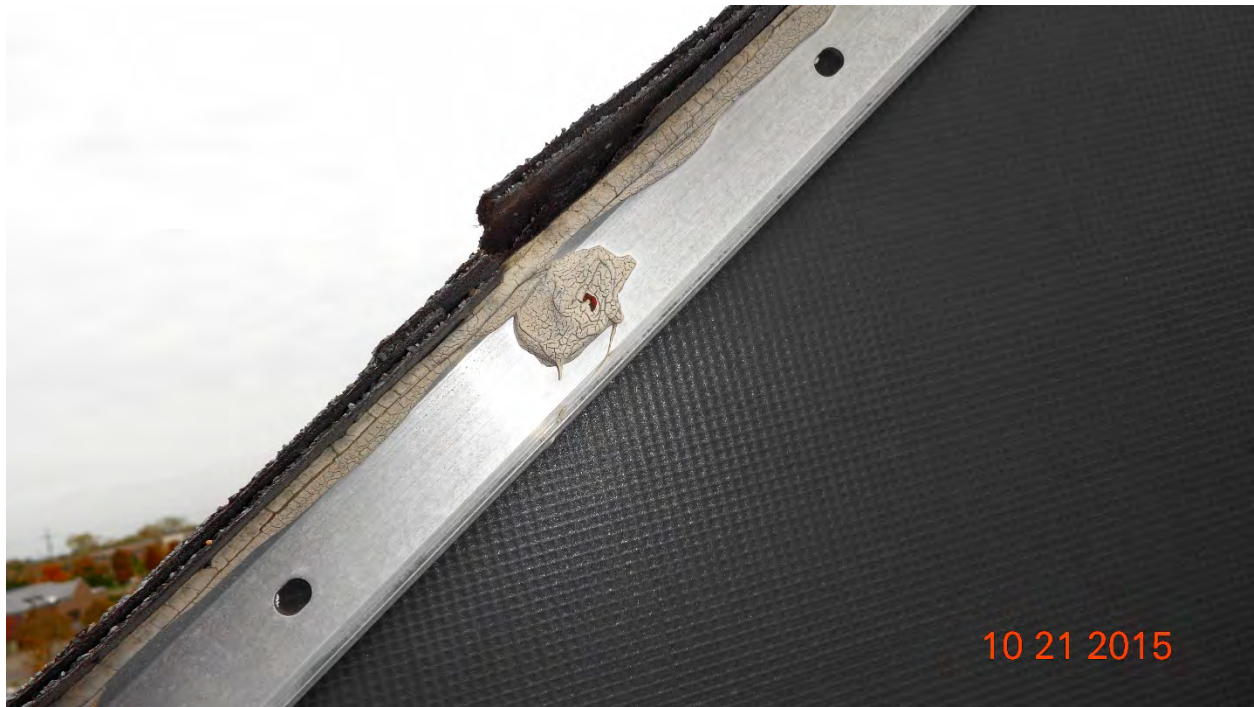
Roof-North End

Caulk at Asphalt Roof Shingles

**No Asbestos Detected**

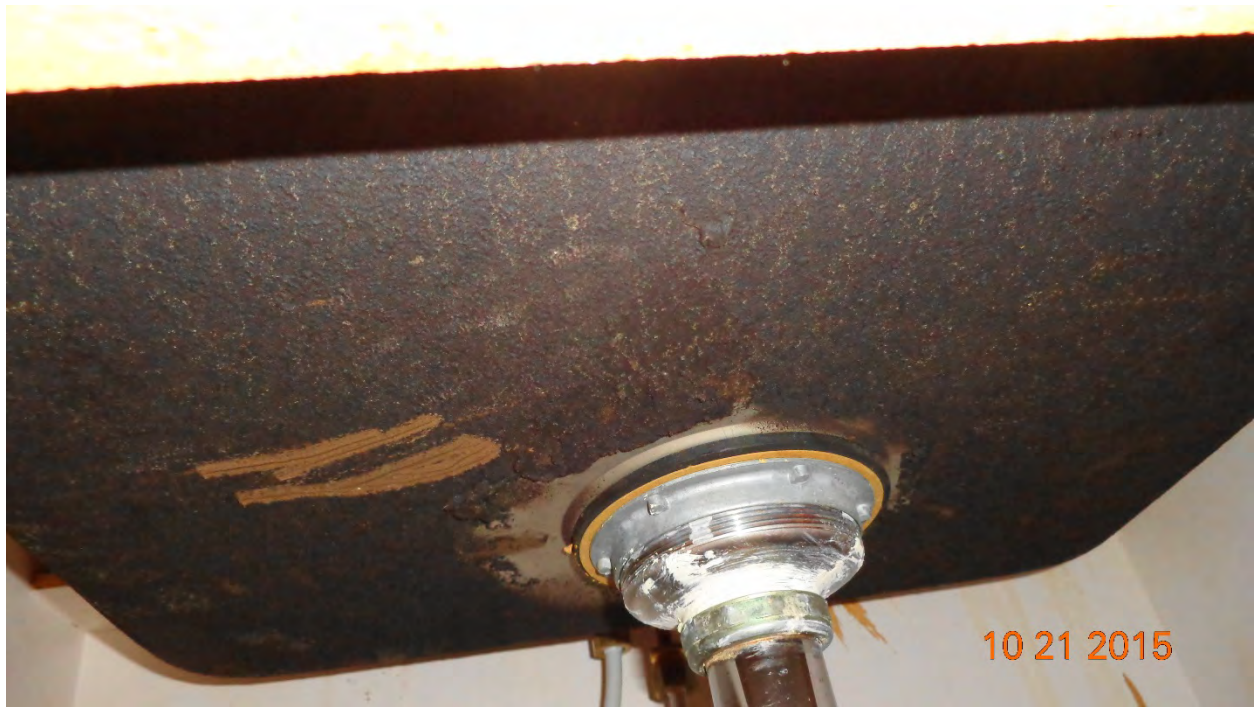
Ground Floor-Pharmacy

Stainless Steel Sink Insulation

**No Asbestos Detected**

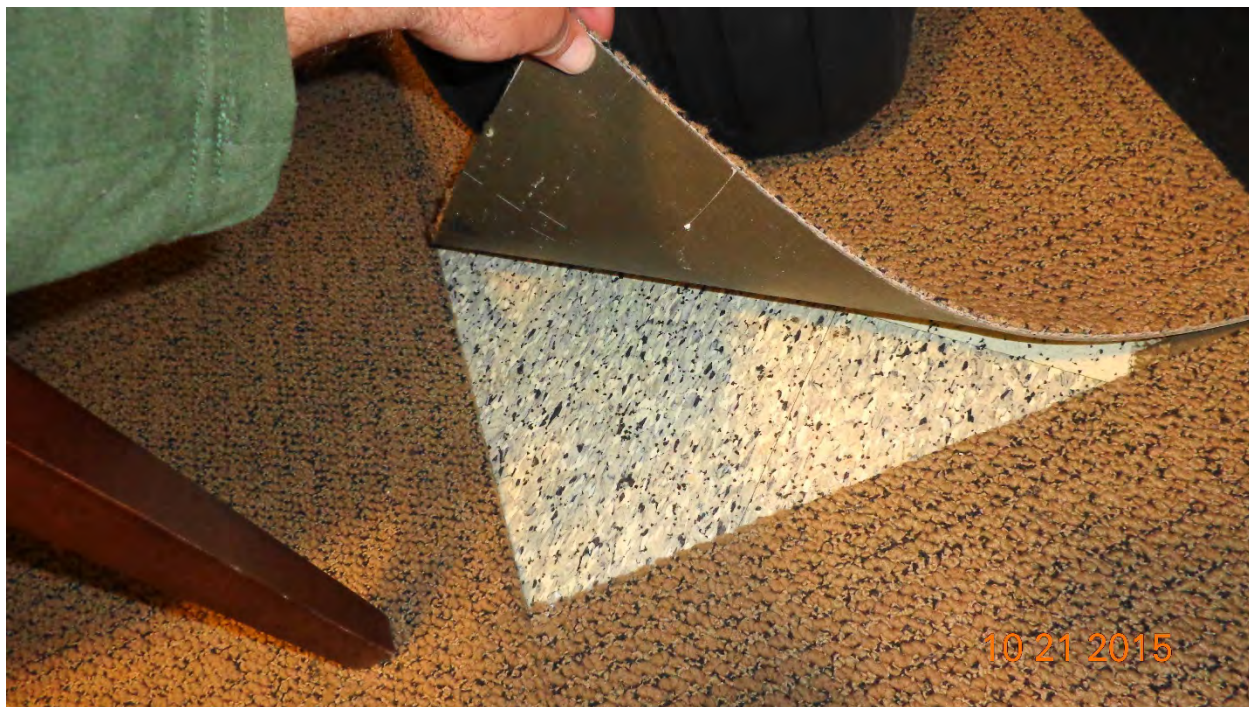
Ground Floor-Bank Area

12" x 12" Grey Speck Pattern Floor Tile and Mastic

**No Asbestos Detected**

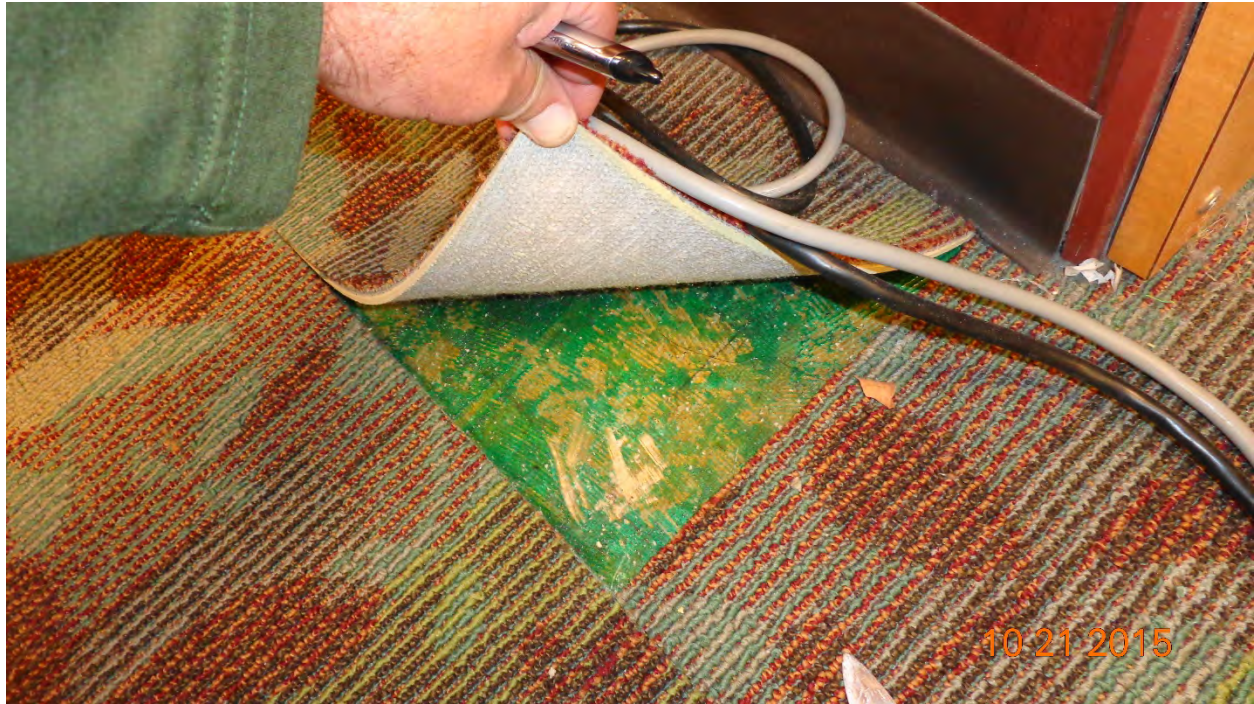
Ground Floor-Pharmacy

Carpet Mastic

**No Asbestos Detected**

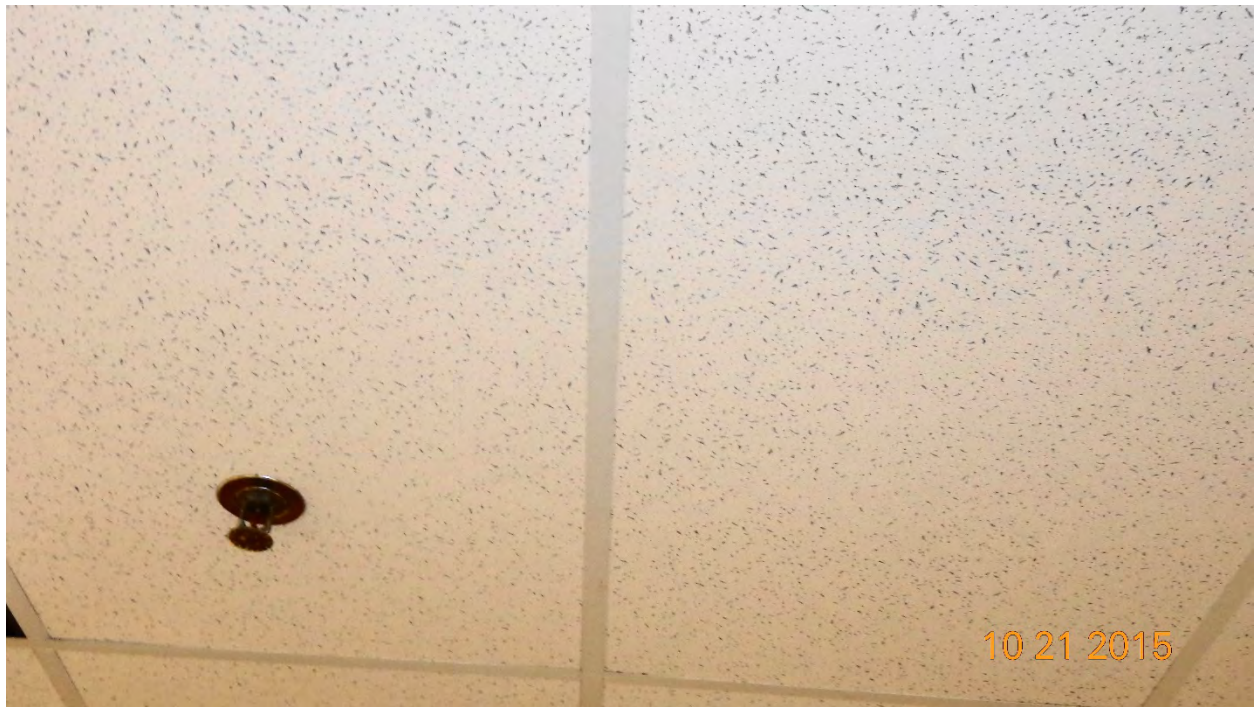
Ground Floor-Pharmacy

2' x 4' Birdtrack Pattern Ceiling Tile

**No Asbestos Detected**

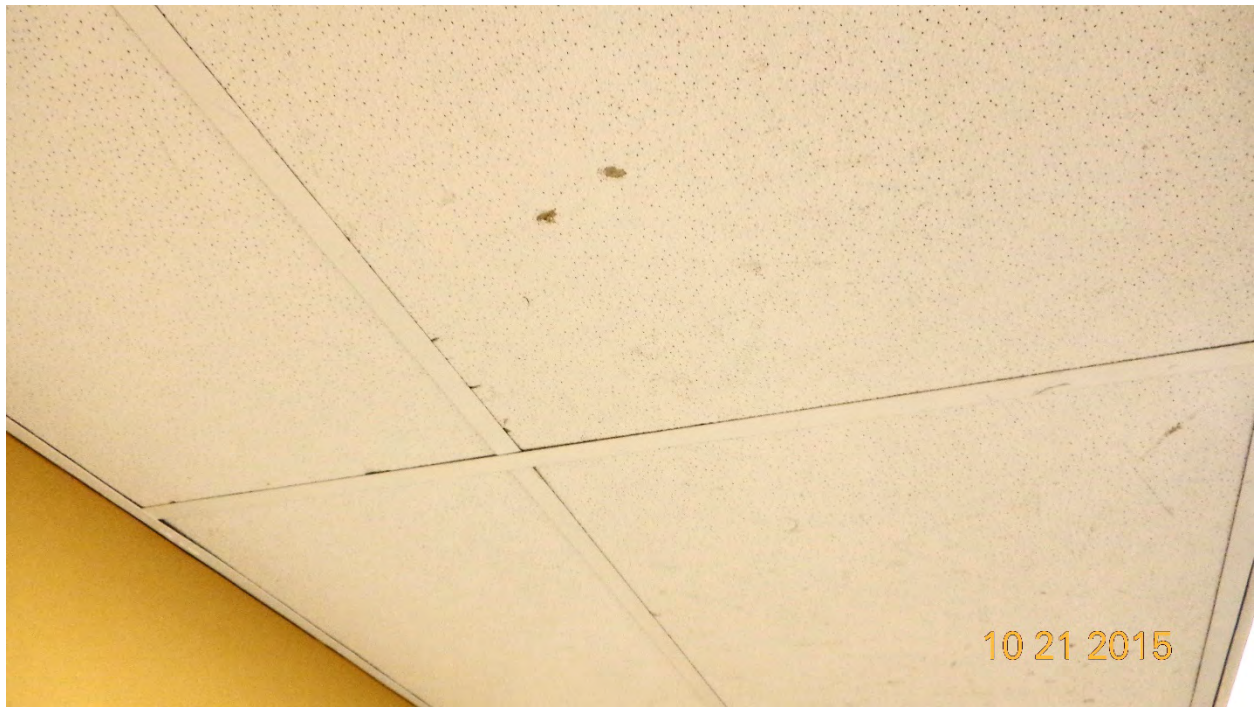
Ground Floor-South Entry

2' x 4' Pinhole Pattern Ceiling Tile

**No Asbestos Detected**

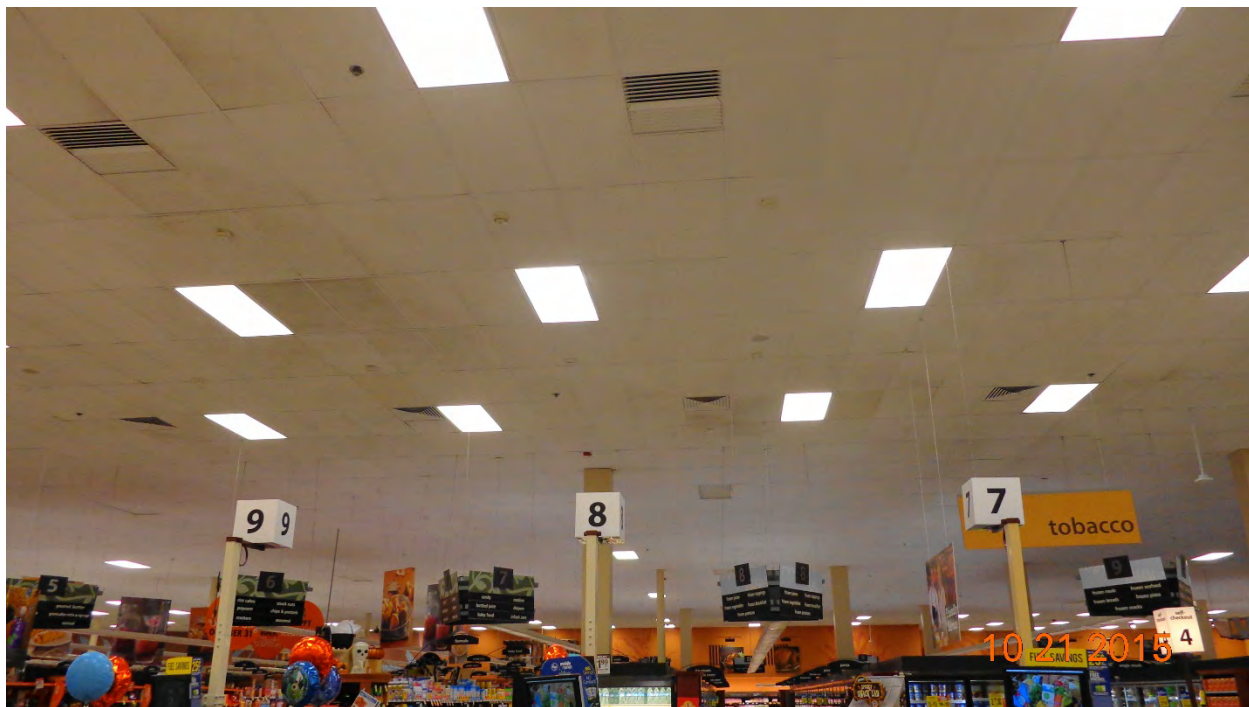
Ground Floor-Main Sales Area

2' x 4' Pinhole Pattern Ceiling Tile

**No Asbestos Detected**

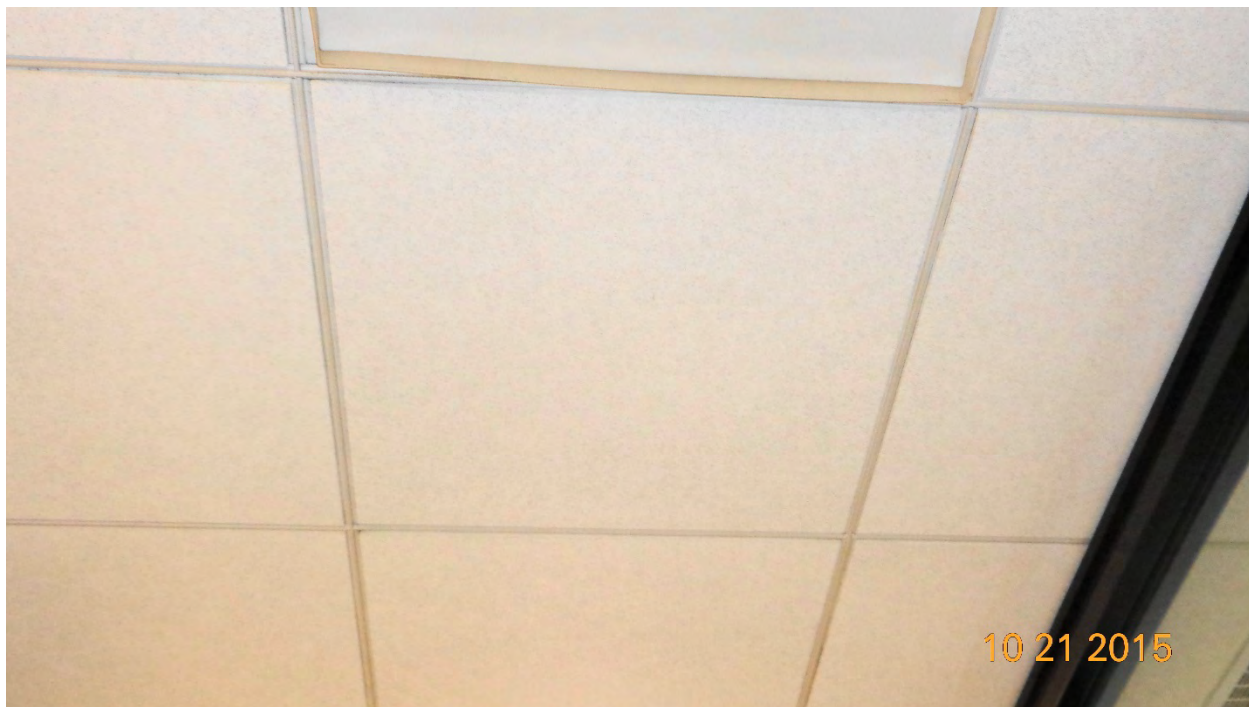
Ground Floor-Bank Area

2' x 2' Textured Pattern Ceiling Tile

**No Asbestos Detected**

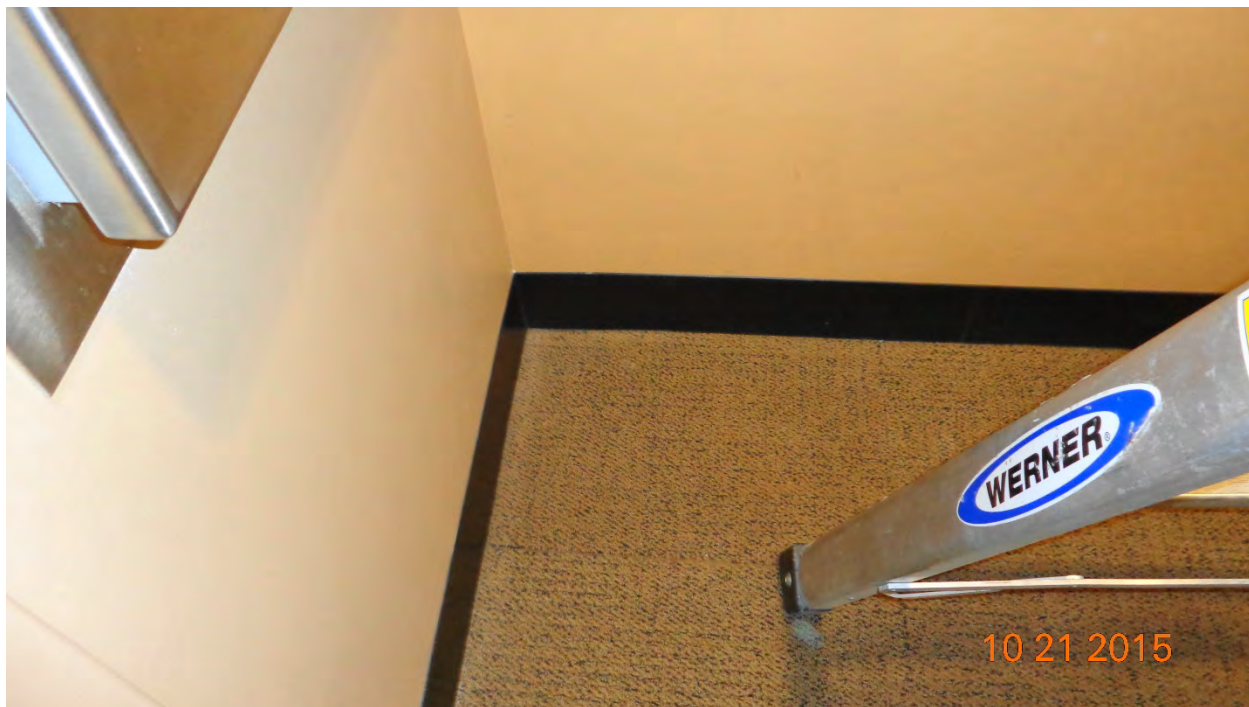
Ground Floor-Bank Area

Black Cove Base Molding and Mastic

**No Asbestos Detected**

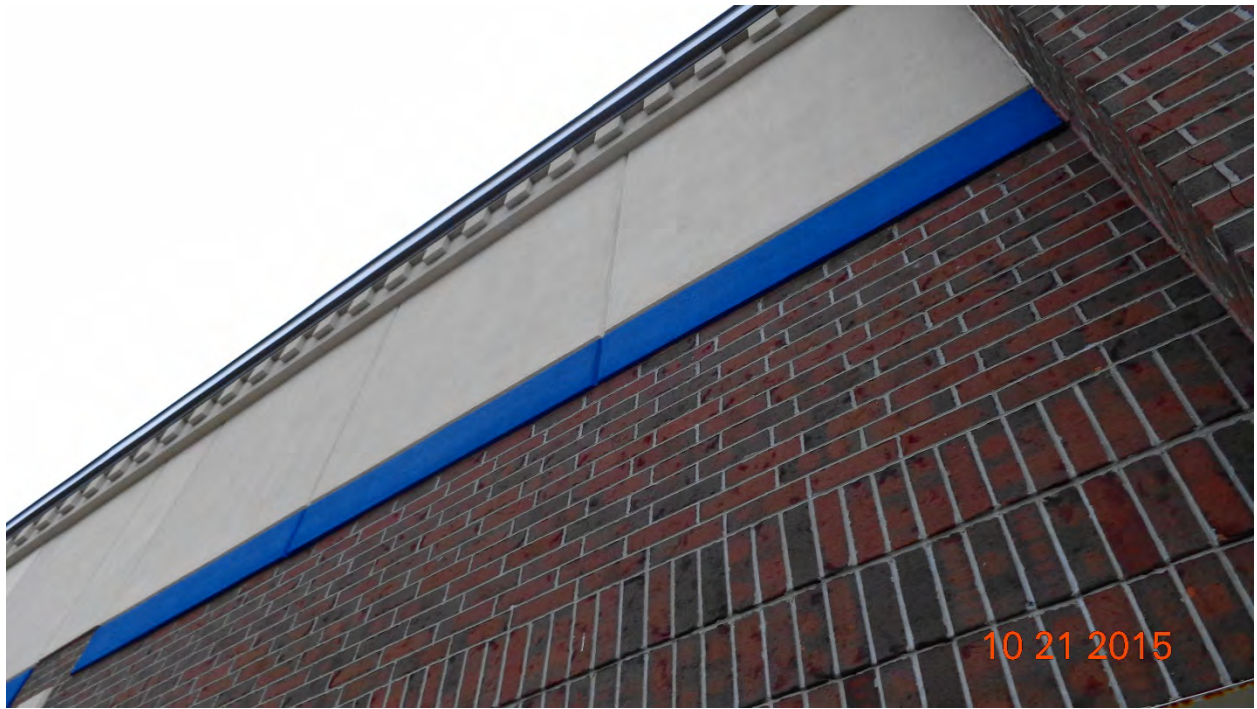
Exterior-South End

Exterior Finishing System

**No Asbestos Detected**

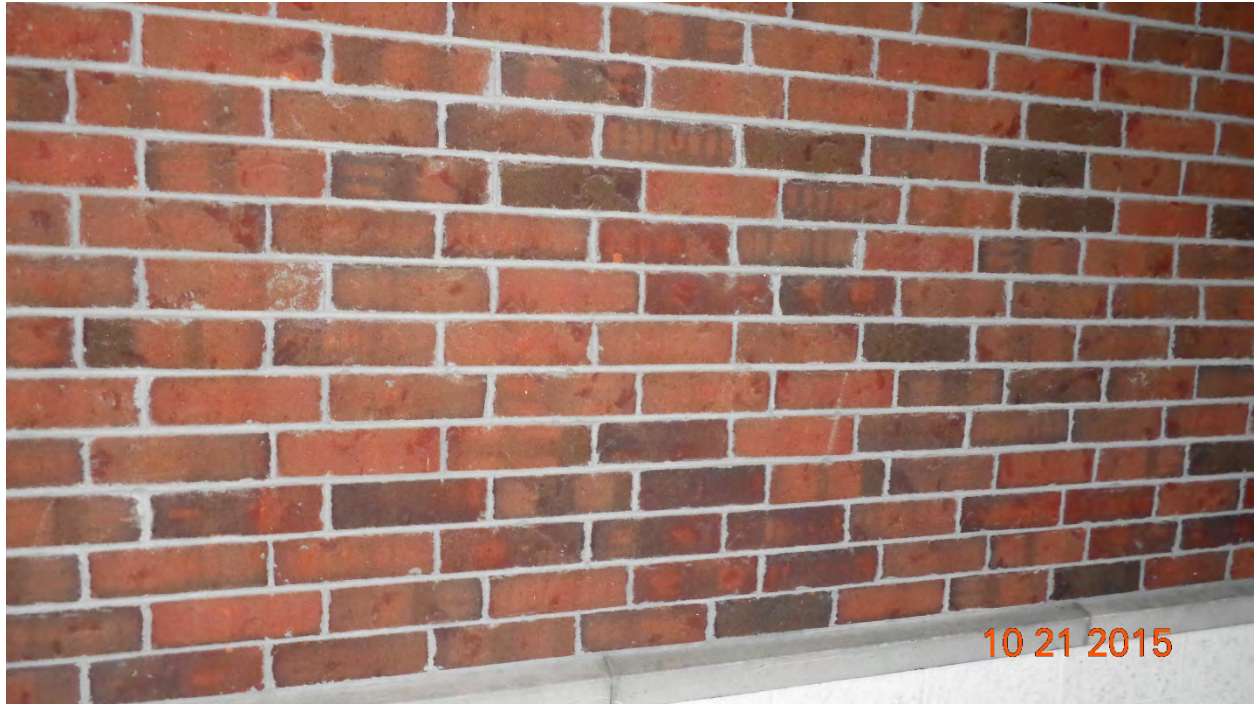
Exterior-East End

Brick Mortar

**No Asbestos Detected**

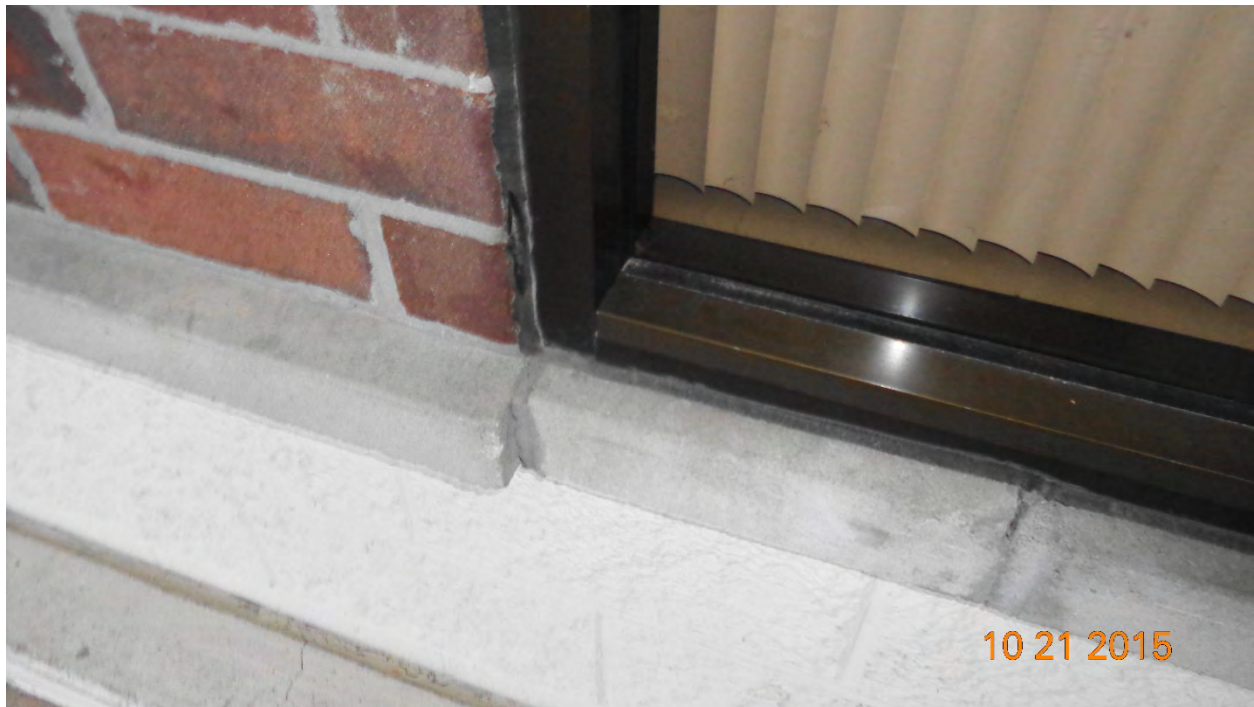
Exterior-South End

Door/Window Caulk

**No Asbestos Detected**

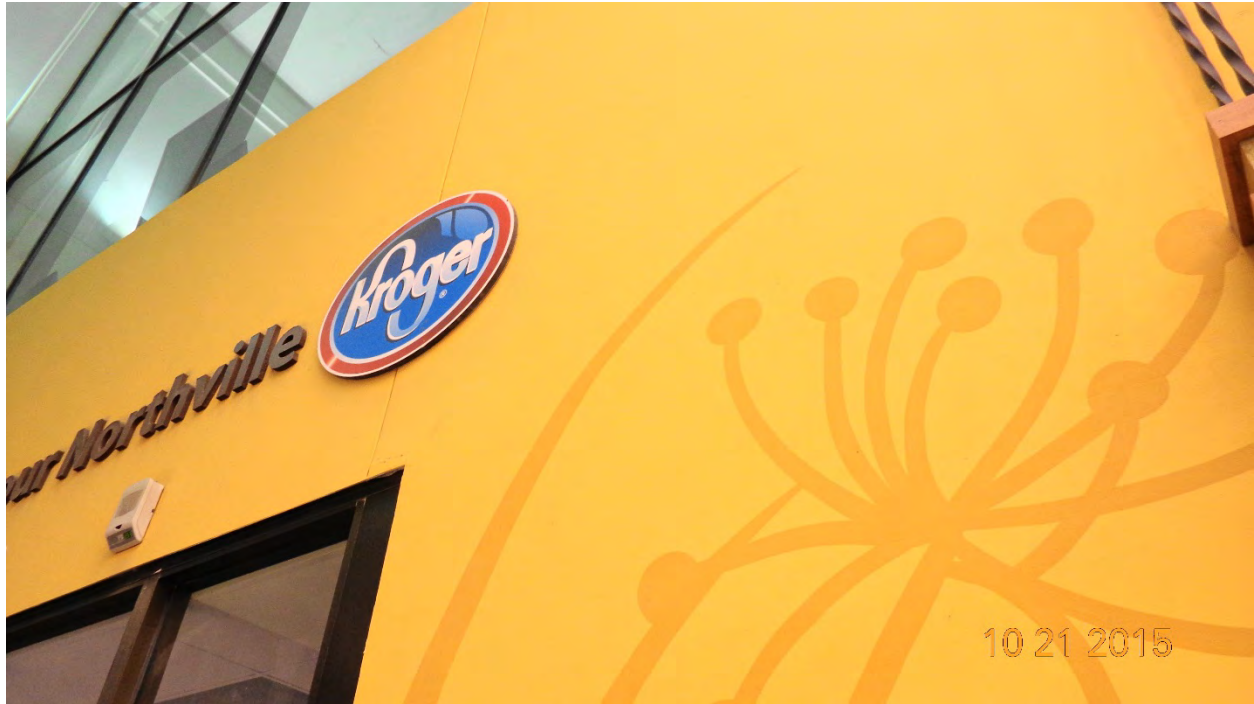
Ground Floor-Vestibule

Drywall and Associated Joint Compound

**No Asbestos Detected**

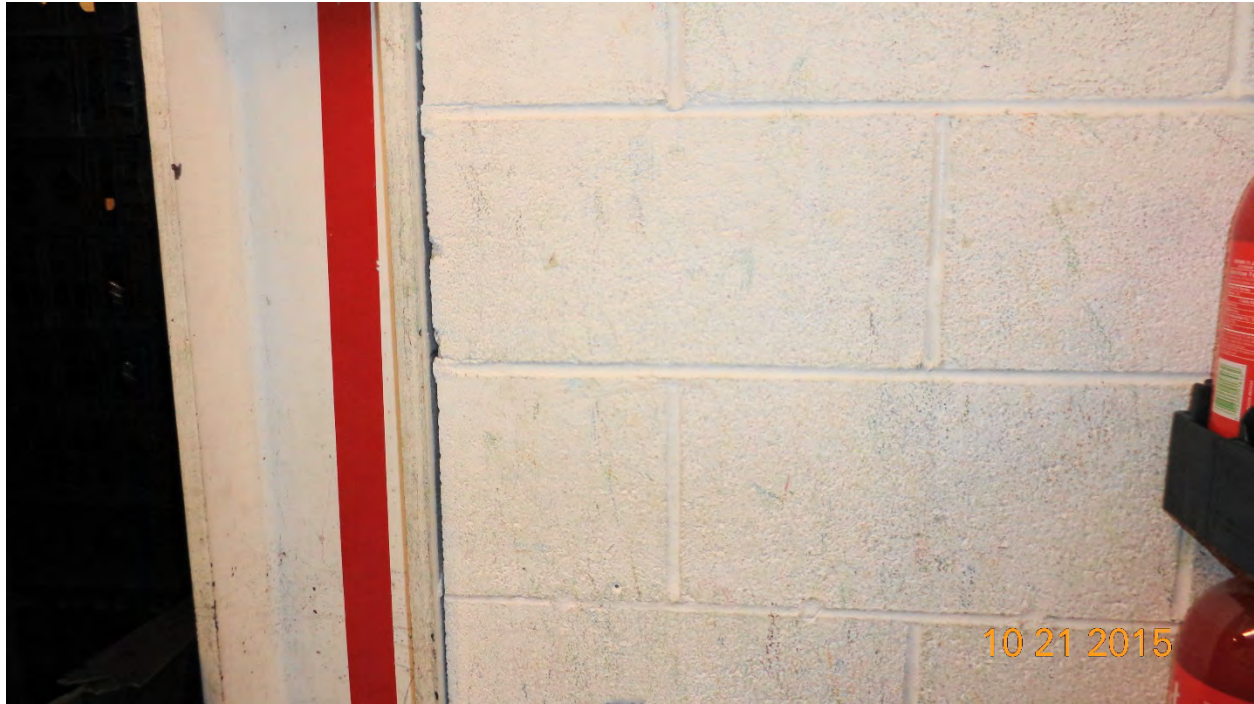
Ground Floor-Warehouse Area

Concrete Block Mortar

**No Asbestos Detected**

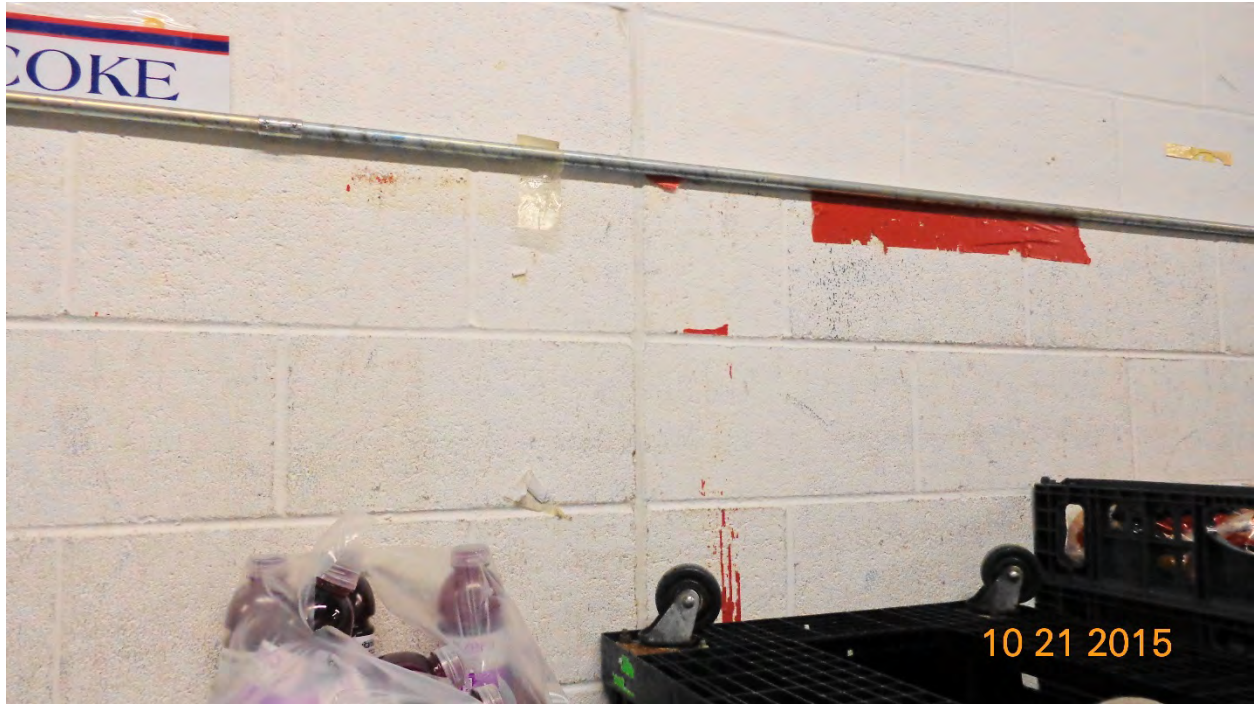
Ground Floor-Warehouse Area

Concrete Block Expansion Joint

**No Asbestos Detected**

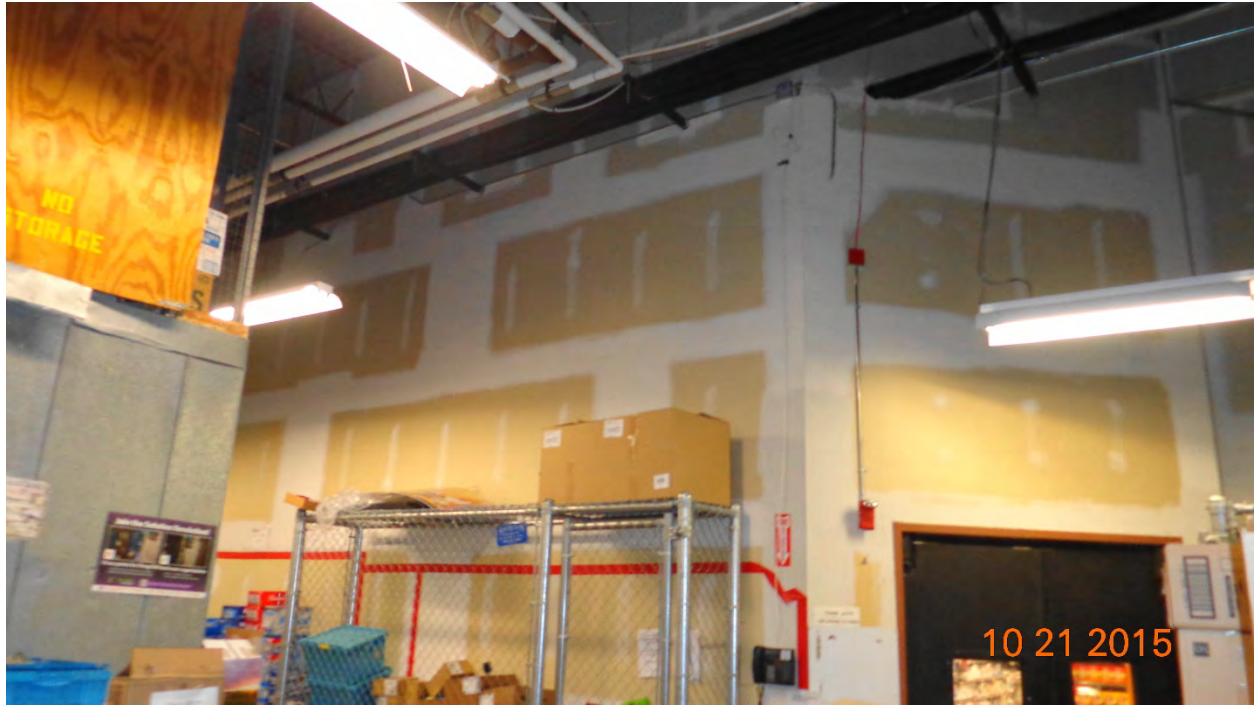
Ground Floor-Dock Area

Drywall and Associated Joint Compound

**No Asbestos Detected**

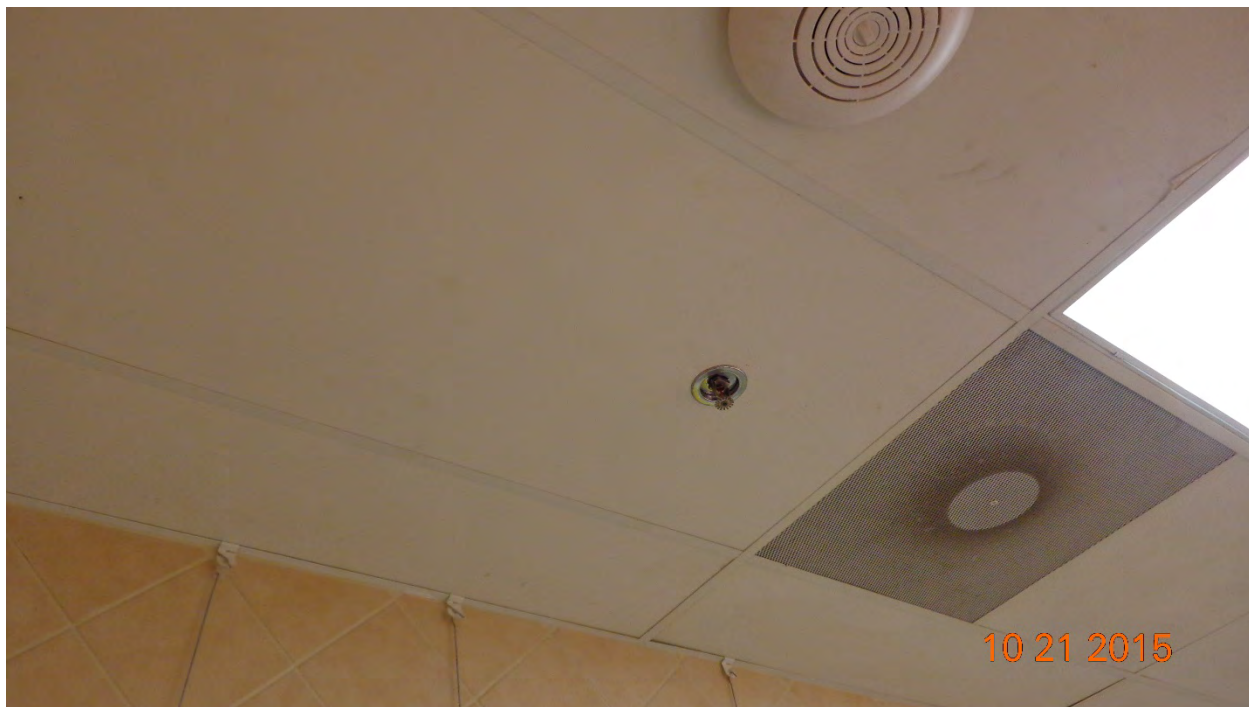
Ground Floor-Meat Department

2' x 4' Smooth Pattern Ceiling Tile

**No Asbestos Detected**

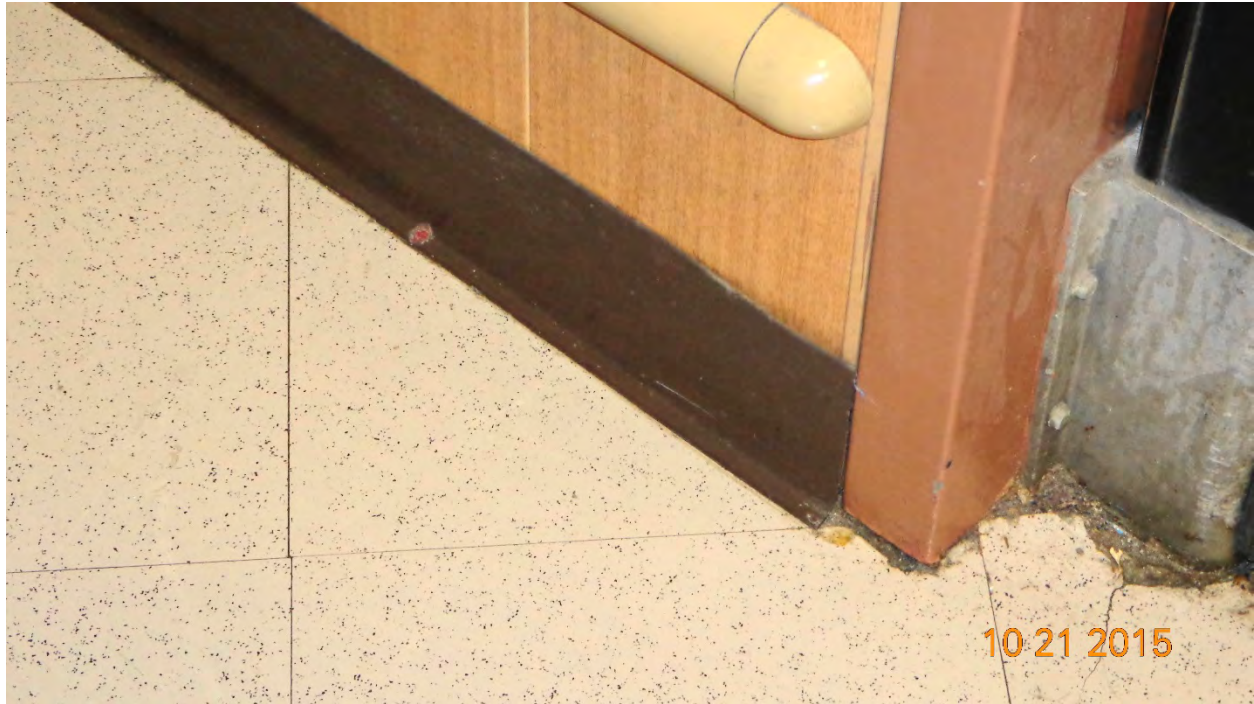
Ground Floor-Main Sales Area

Brown Cove Base Molding and Mastic

**No Asbestos Detected**

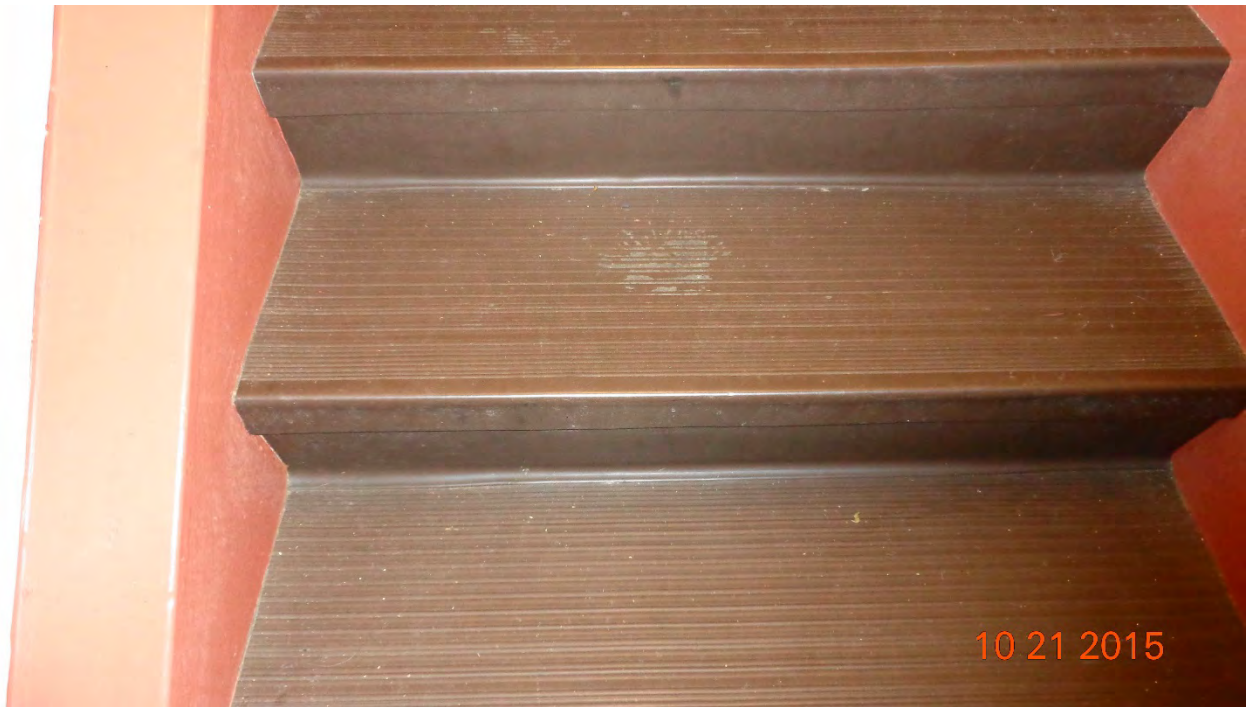
Mezzanine-Stairwell

Stair Treads and Adhesive

**No Asbestos Detected**
