**RE: Asbestos Survey Report  
Kroger Store D-442 Renovation  
17447 Haggerty Road  
Northville, Michigan  
Project No. 343-681.0001**

**NESHAP Renovation Asbestos Survey Report**

**Existing Kroger Store D-442  
17447 Haggerty Road  
Northville, Michigan 48168**

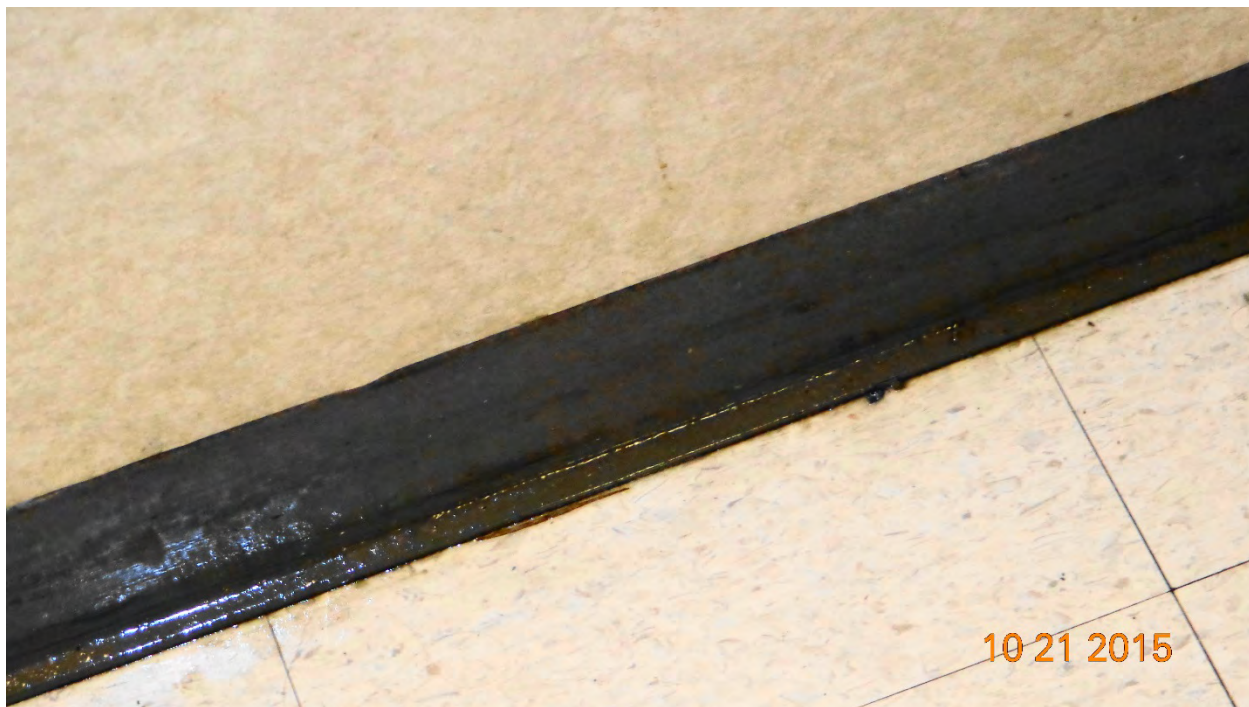
Mezzanine-Hallway

Grey Cove Base Molding and Mastic

**No Asbestos Detected**

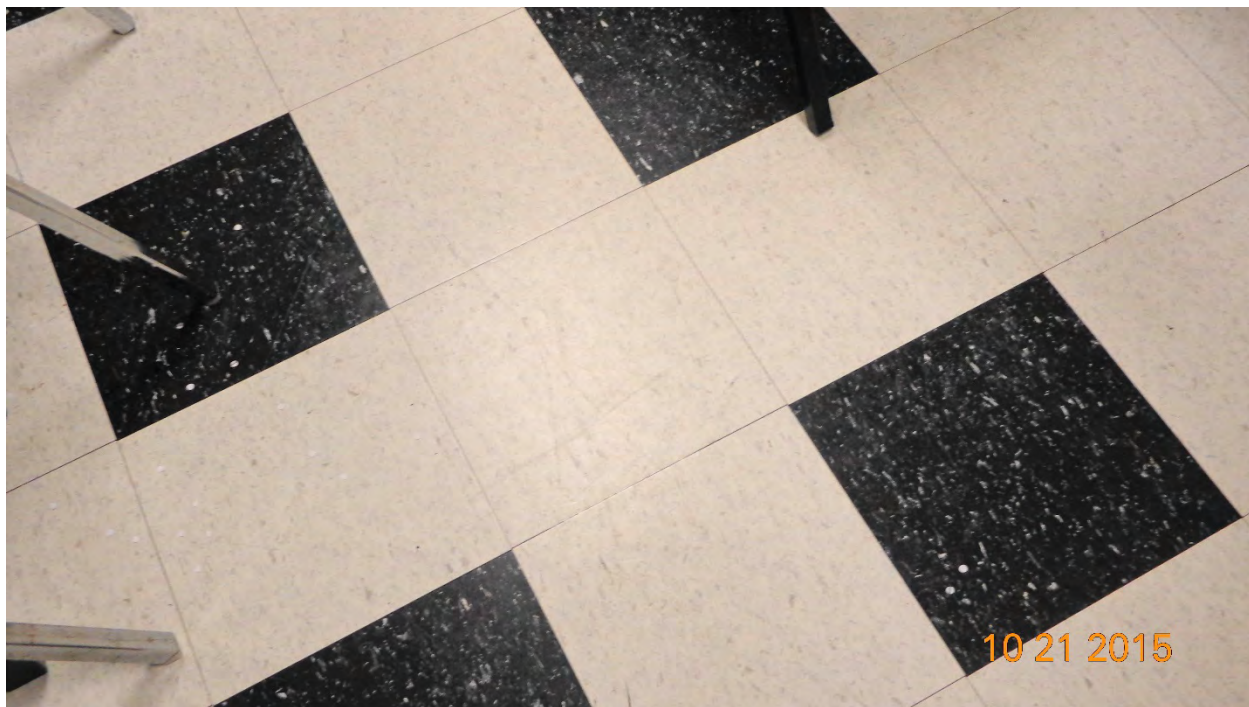
Mezzanine-Offices

12" x 12" Black Scale Pattern Floor Tile and Mastic

**No Asbestos Detected**

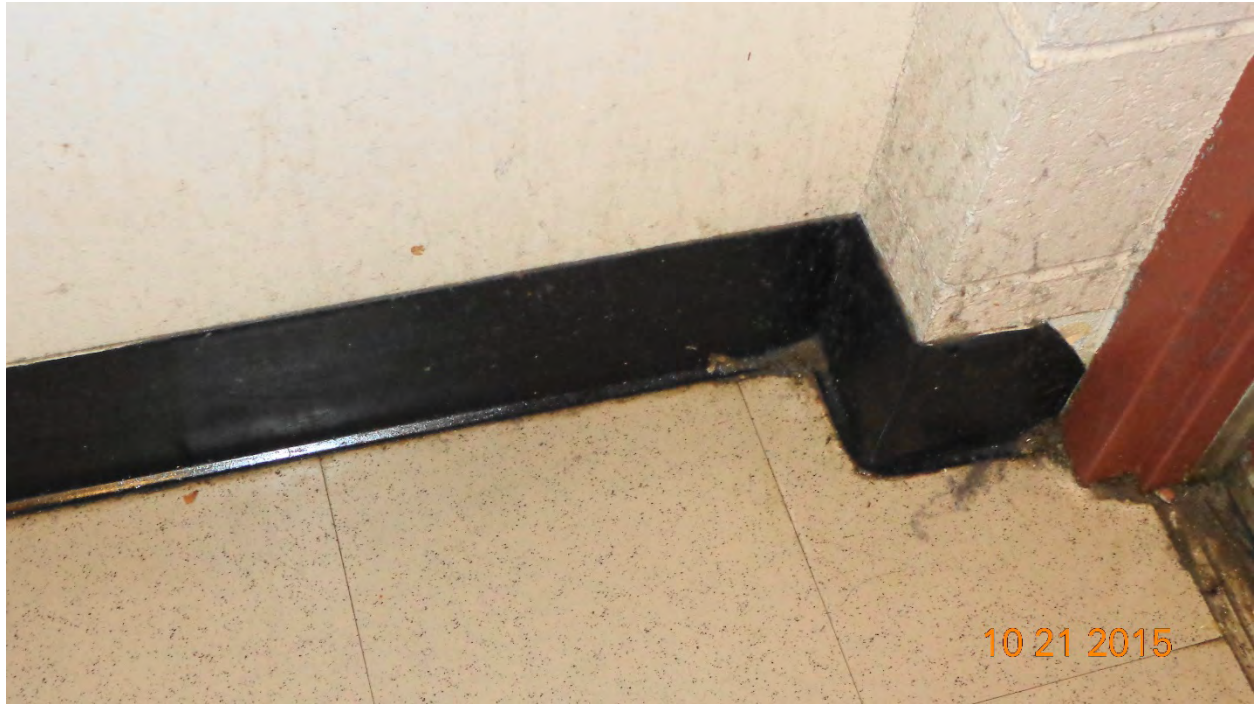
Mezzanine-Hallway

Black Cove Base Molding and Mastic

**No Asbestos Detected**

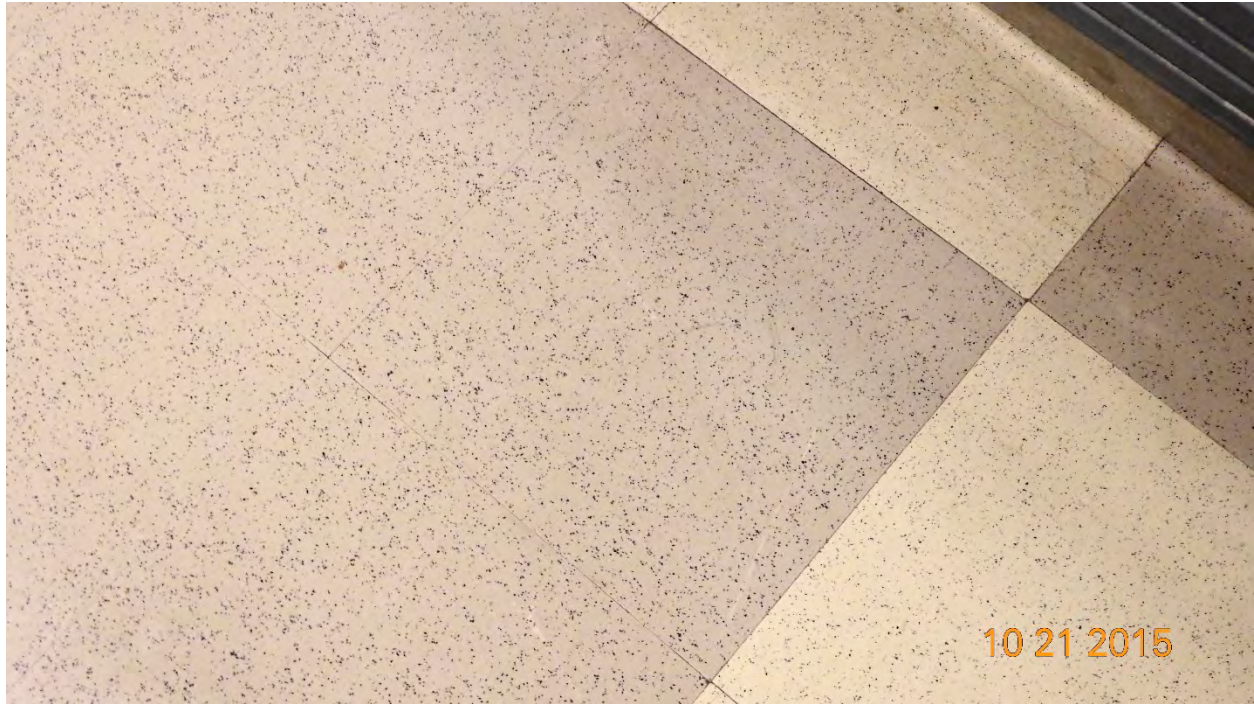
Ground Floor-Produce Area

12" x 12" Grey with Dot Pattern Floor Tile and Mastic

**No Asbestos Detected**

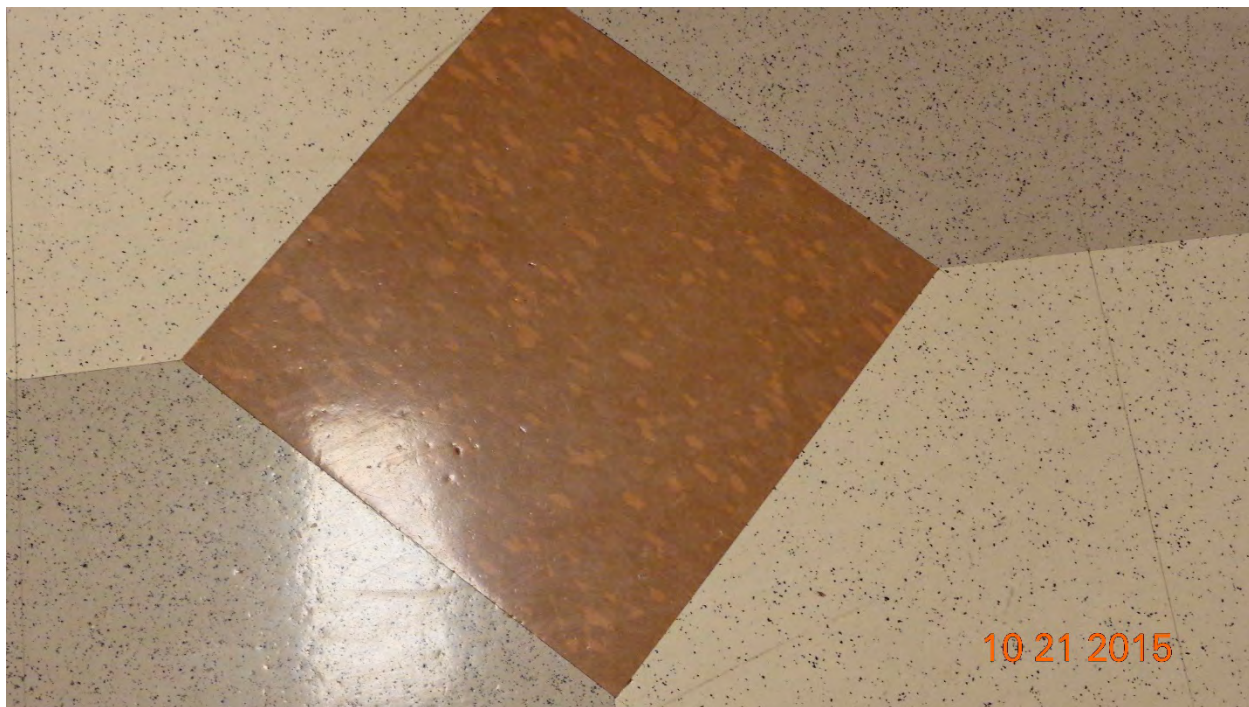
Ground Floor-Produce Area

12" x 12" Brown Scale Pattern Floor Tile and Mastic

**No Asbestos Detected**

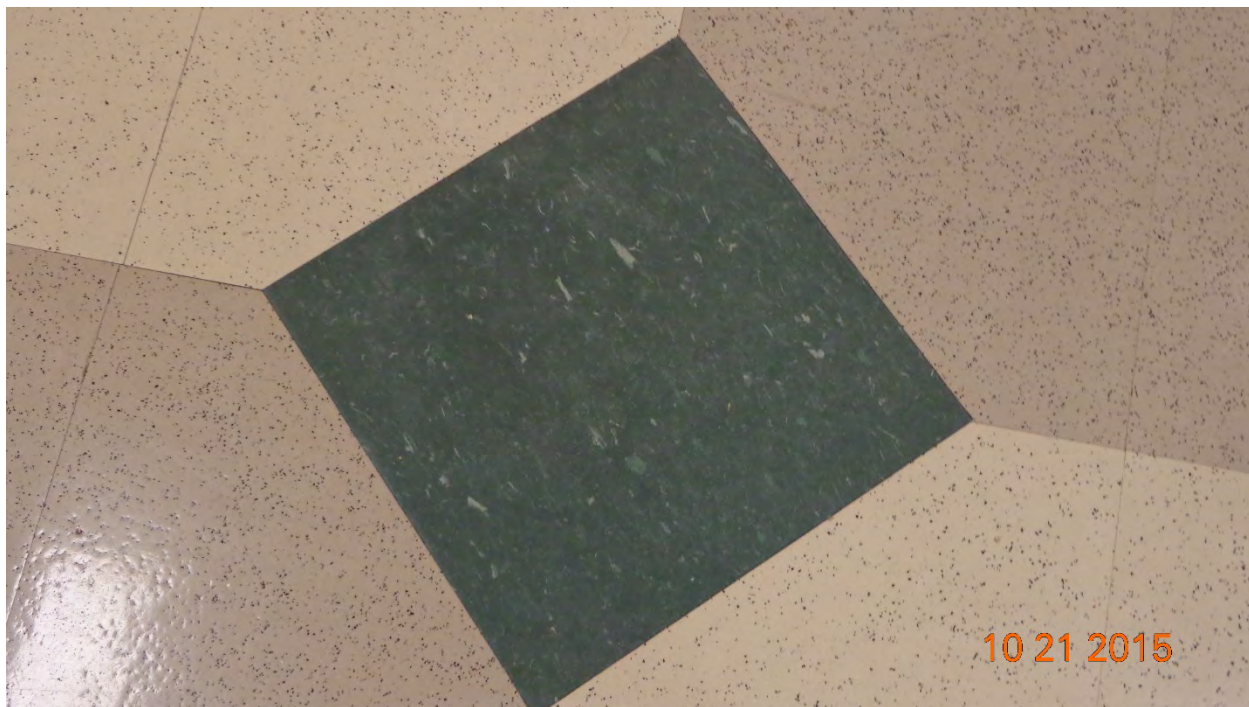
Ground Floor-Produce Area

12" x 12" Green Scale Pattern Floor Tile and Mastic

**No Asbestos Detected**
