**RE: Asbestos Survey Report  
Kroger Store D-442 Renovation  
17447 Haggerty Road  
Northville, Michigan  
Project No. 343-681.0001**

**NESHAP Renovation Asbestos Survey Report**

**Existing Kroger Store D-442  
17447 Haggerty Road  
Northville, Michigan 48168**

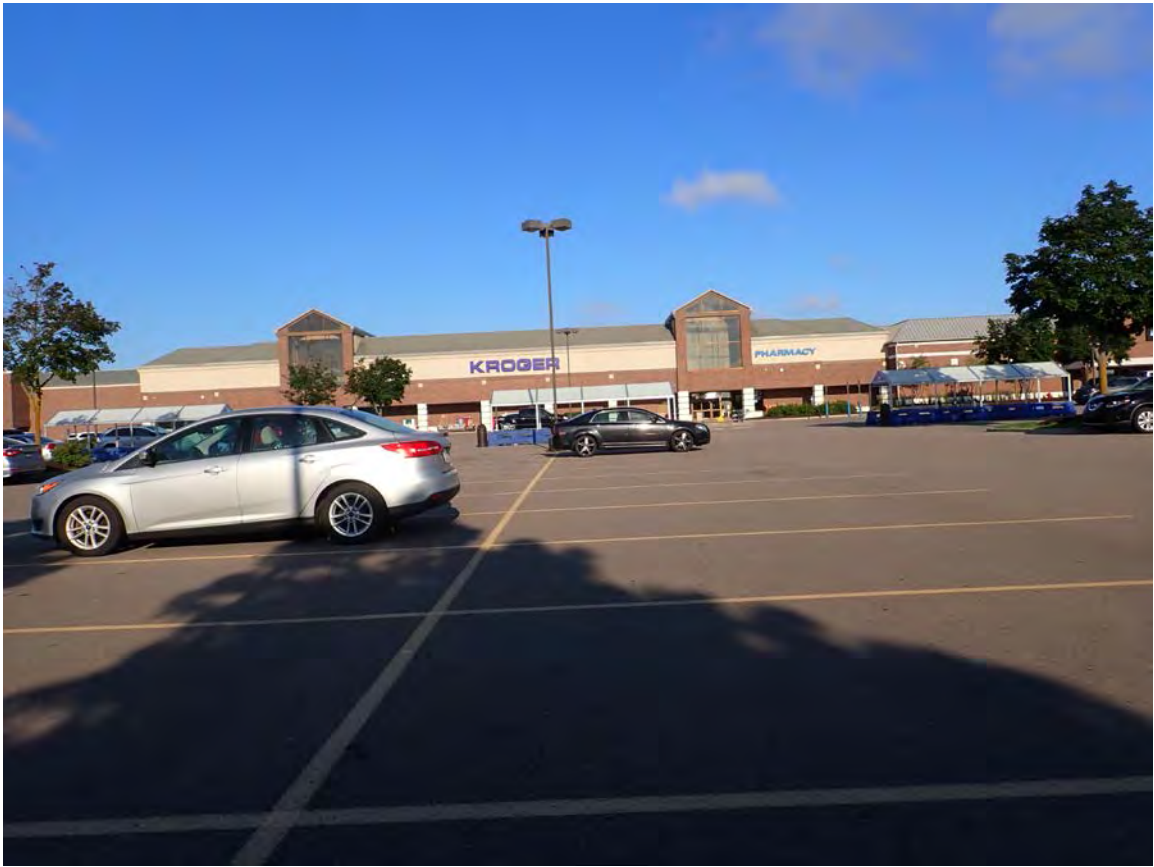
**Exterior Photo**

**Existing Kroger Store D-442**  
17447 Haggerty Road  
Northville, Michigan 48168

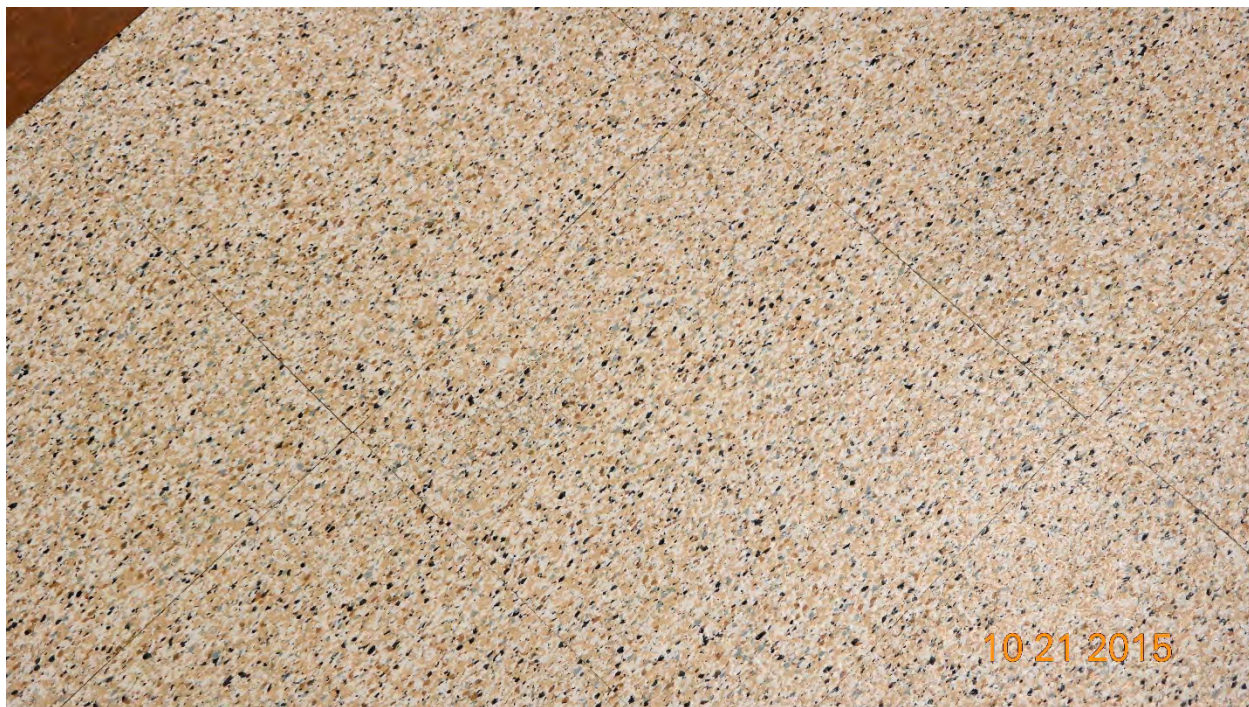
12" x 12" Green Scale Pattern Floor Tile and Mastic

**No Asbestos Detected**

Ground Floor-Produce Area
